Comphort Technical Services

Tree assessment at, 212 Churchill Road, Prospect on 2024-08-23

The purpose of this report is to identify potential impacts these trees may have on development, neighbouring properties and persons using the area within the vicinity.

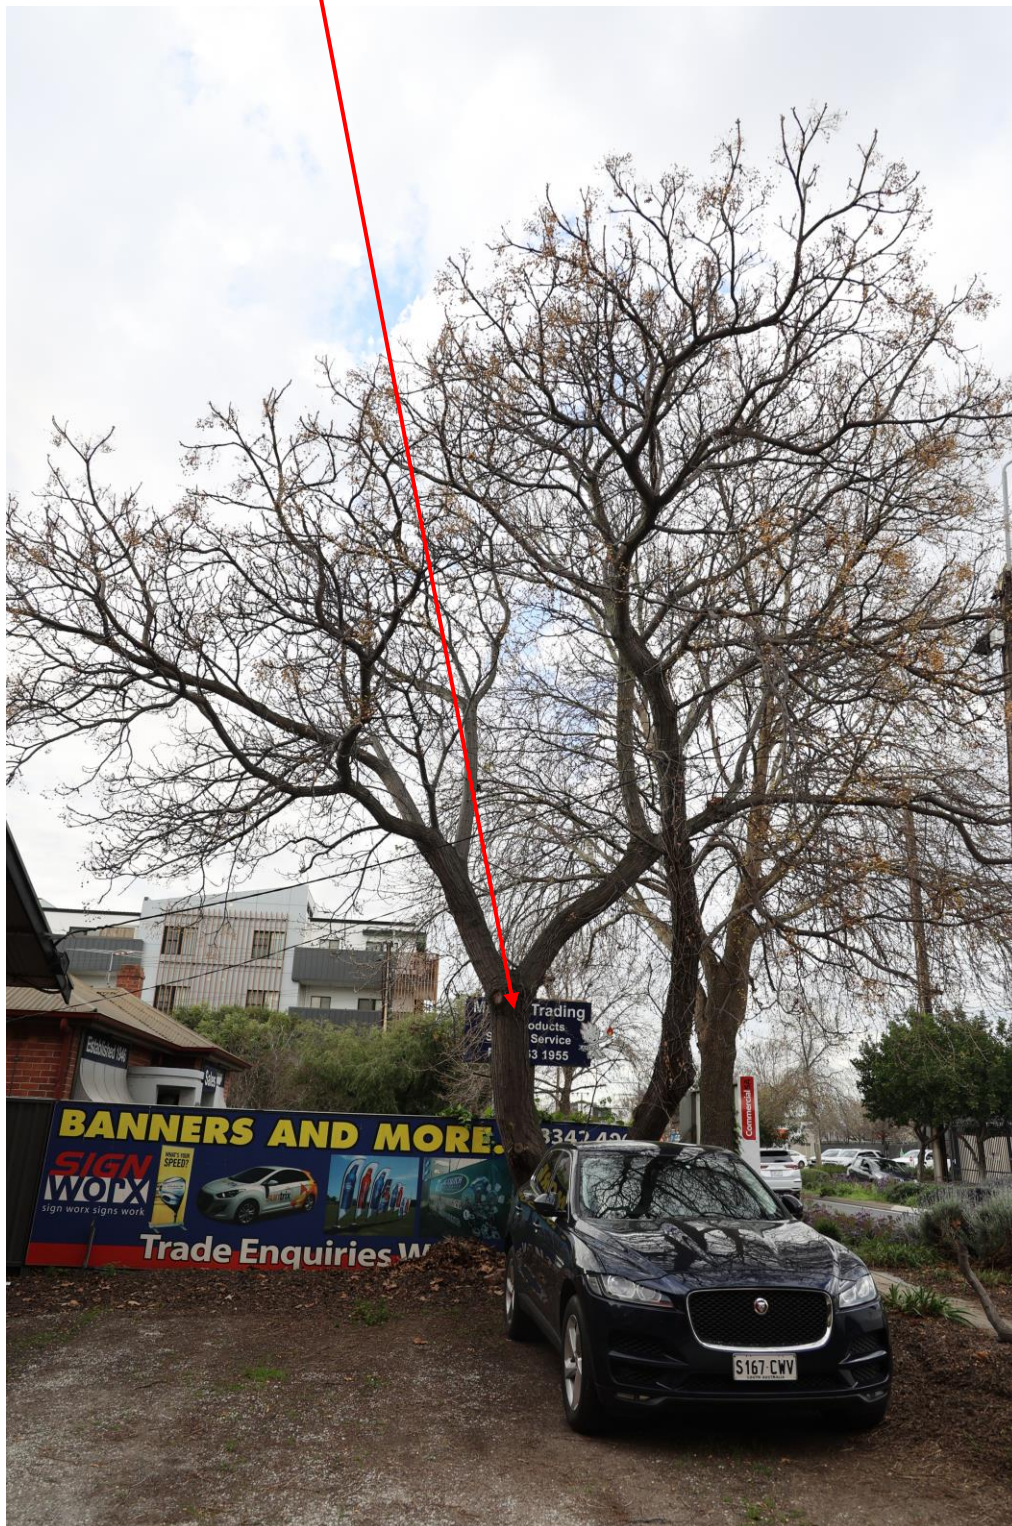
Tree species: *Melia azedarach* (White Cedar)

Height of tree: Approximately 8.8m

Circumference 1m above ground level: 1.2m/1.45m (2 leaders)

DBH (Diameter at Breast Height): 36cm/46cm (Combined = 58.4cm)

Current condition: This Melia is in an average condition with multiple leaders off an old stump next to the fence.

This tree isn't the most aesthetic looking Melia with its two leaders and heavy lean to the south but it is healthy and I cannot justify the removal of this tree for those reasons. The legislation below has to justify the removal of this tree.

The tree is not diseased or have a short life expectancy, it doesn't pose a risk at present to the public or private. It is not damaging any building or in a bushfire risk area. As the owner have proposed to build multi storey living units as the same as in 210 Churchill Road and the development would not proceed unless the tree was removed.

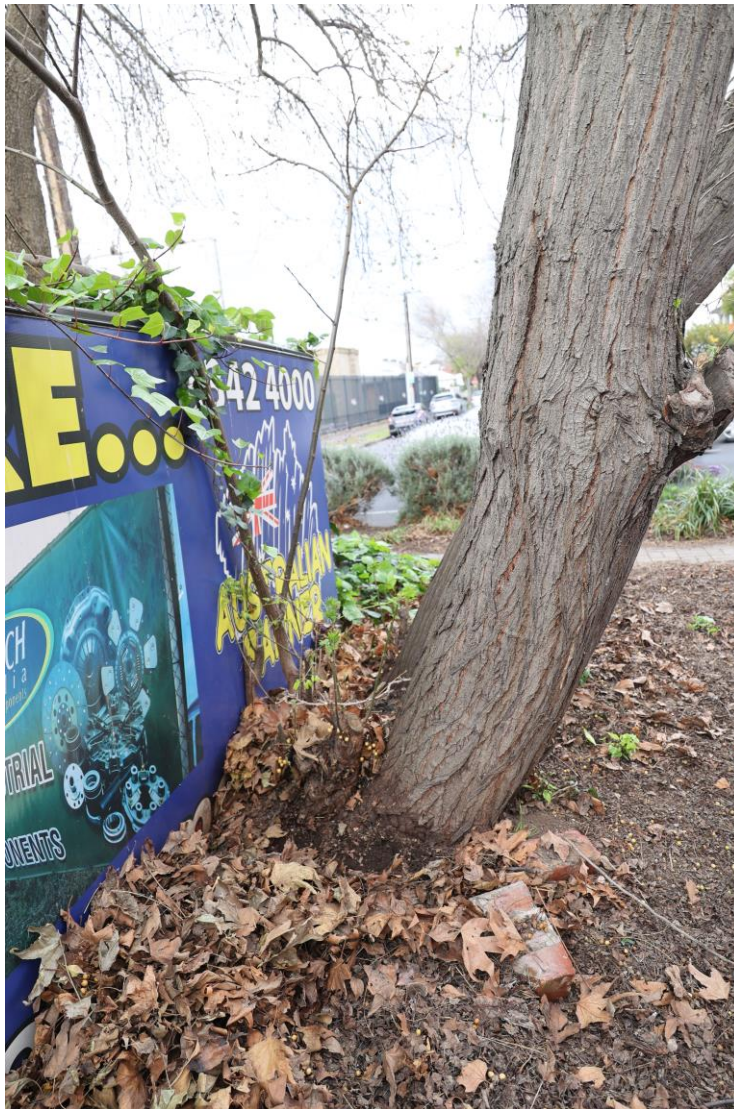
Branch integrity: The majority of branches are in an average condition with minor deadwood branches throughout the canopy. Integrity would be average.

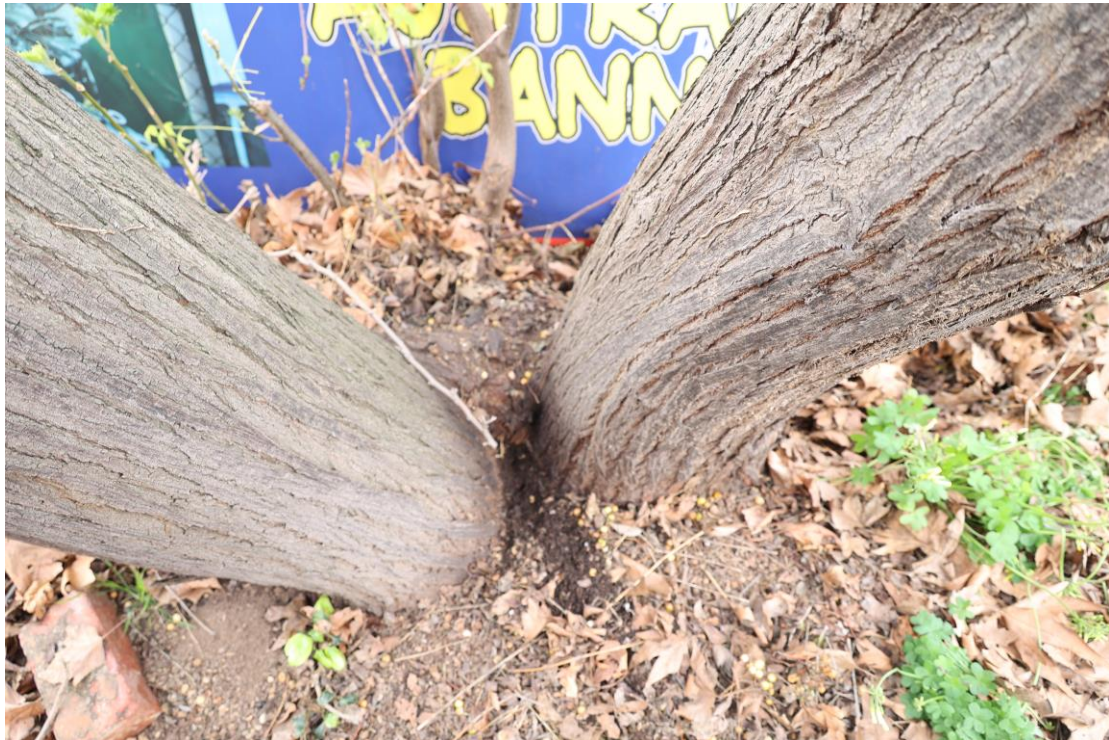
Trunk integrity: The trunks are in a structurally sound condition with minor decay between the trunks. Integrity was good with sound testing indicating good sound timber within the trunk.

Overall trees appearance: Average foliage with a structurally sound heavy leaning trunks.

Any curious growth forms: Two main leaders with heavy lean towards the south.

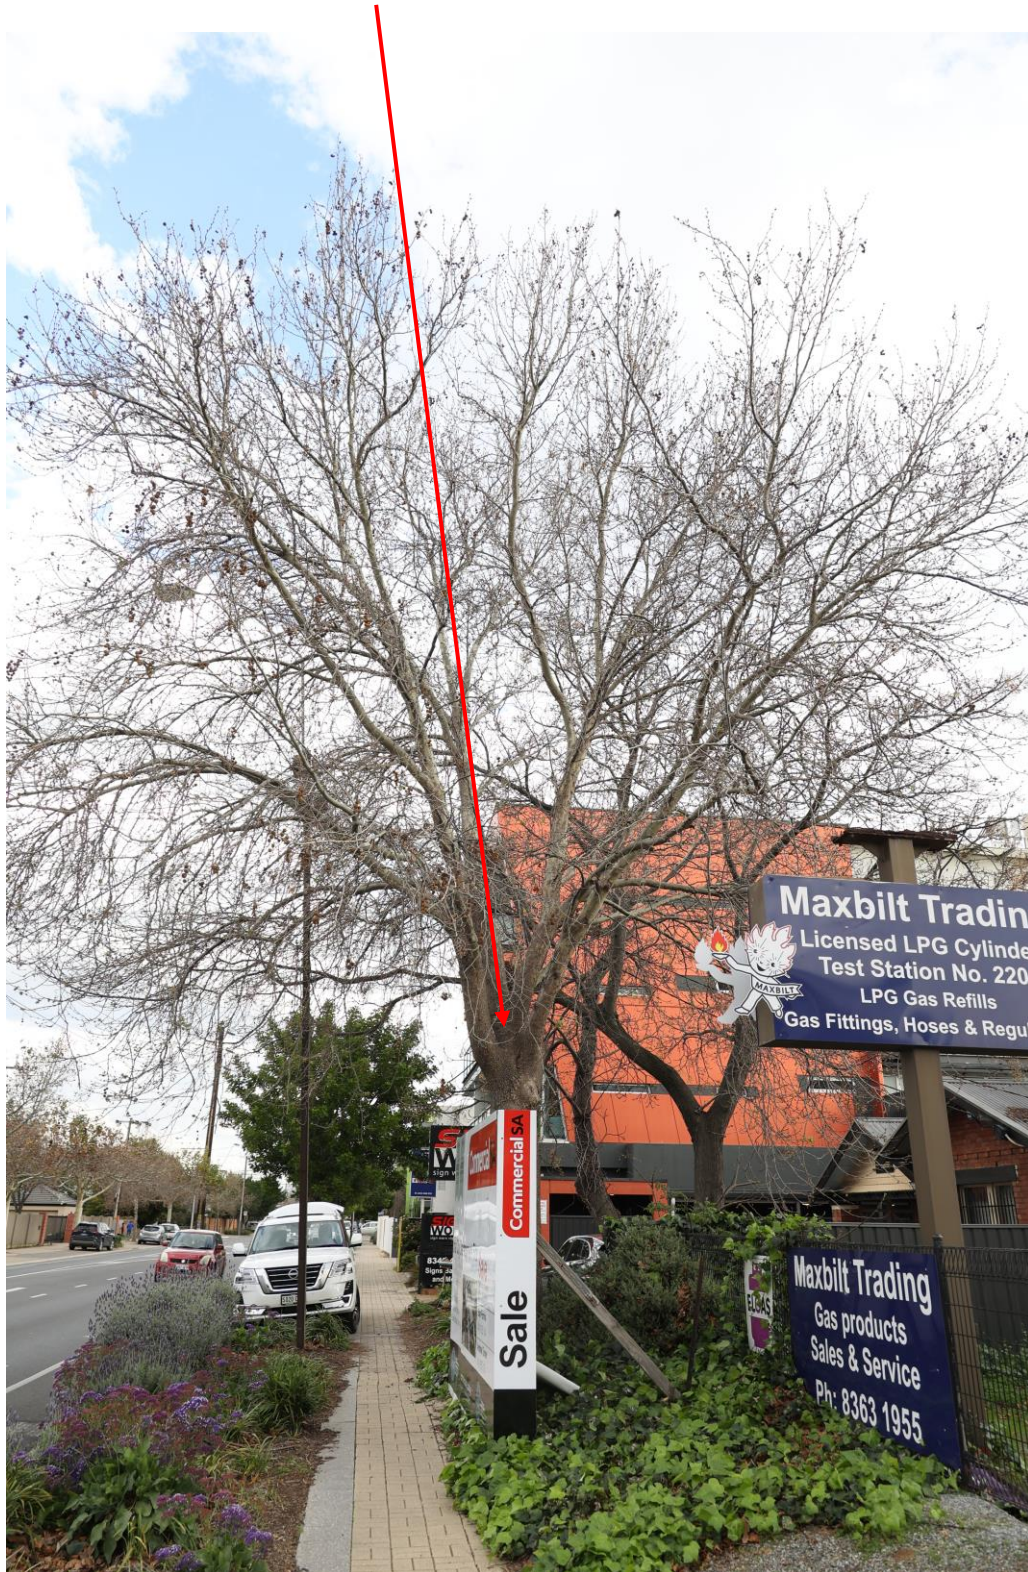
Tree species: *Platanus orientalis* (Oriental Plane Tree)

Height of tree: Approximately 12.5m

Circumference 1m above ground level: 1.85m (Regulated Tree)

Current condition: The tree is very healthy with minor deadwood throughout the canopy.

Trunk integrity: The trunk is in a good condition with no signs of decay. Integrity was good.

As this tree is a council tree, council will have to approve any works within the TPZ of this tree.

At present the property at 212 Churchill Road has an incursion within the TPZ of this tree of 8.7% or 12.5m² and should have little or no effect on any proposed development at 212 Churchill Road, Prospect.
