ENVIRONMENTAL LOG

Client: Adelaide City Council Project: Central West Precinct Location: Franklin St Bus Station and Carparks				Bore No. MW 6 (B) cont.

**Central West Precinct
Remediation Report
Bus Station Site – Stage 1**

Prepared for
Adelaide City Council

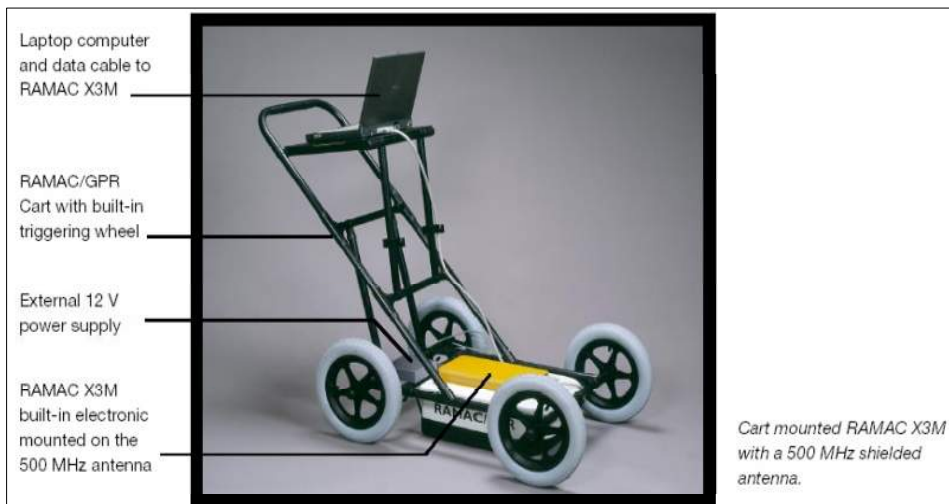
Figure 01. The Mala RAMAC/GPR 500MHz GPR System.

A RAMAC X3M GPR control unit and 500 MHz antenna were used in this investigation (see Figure 01). The RAMAC GPR was developed by Malå GeoScience of Sweden.

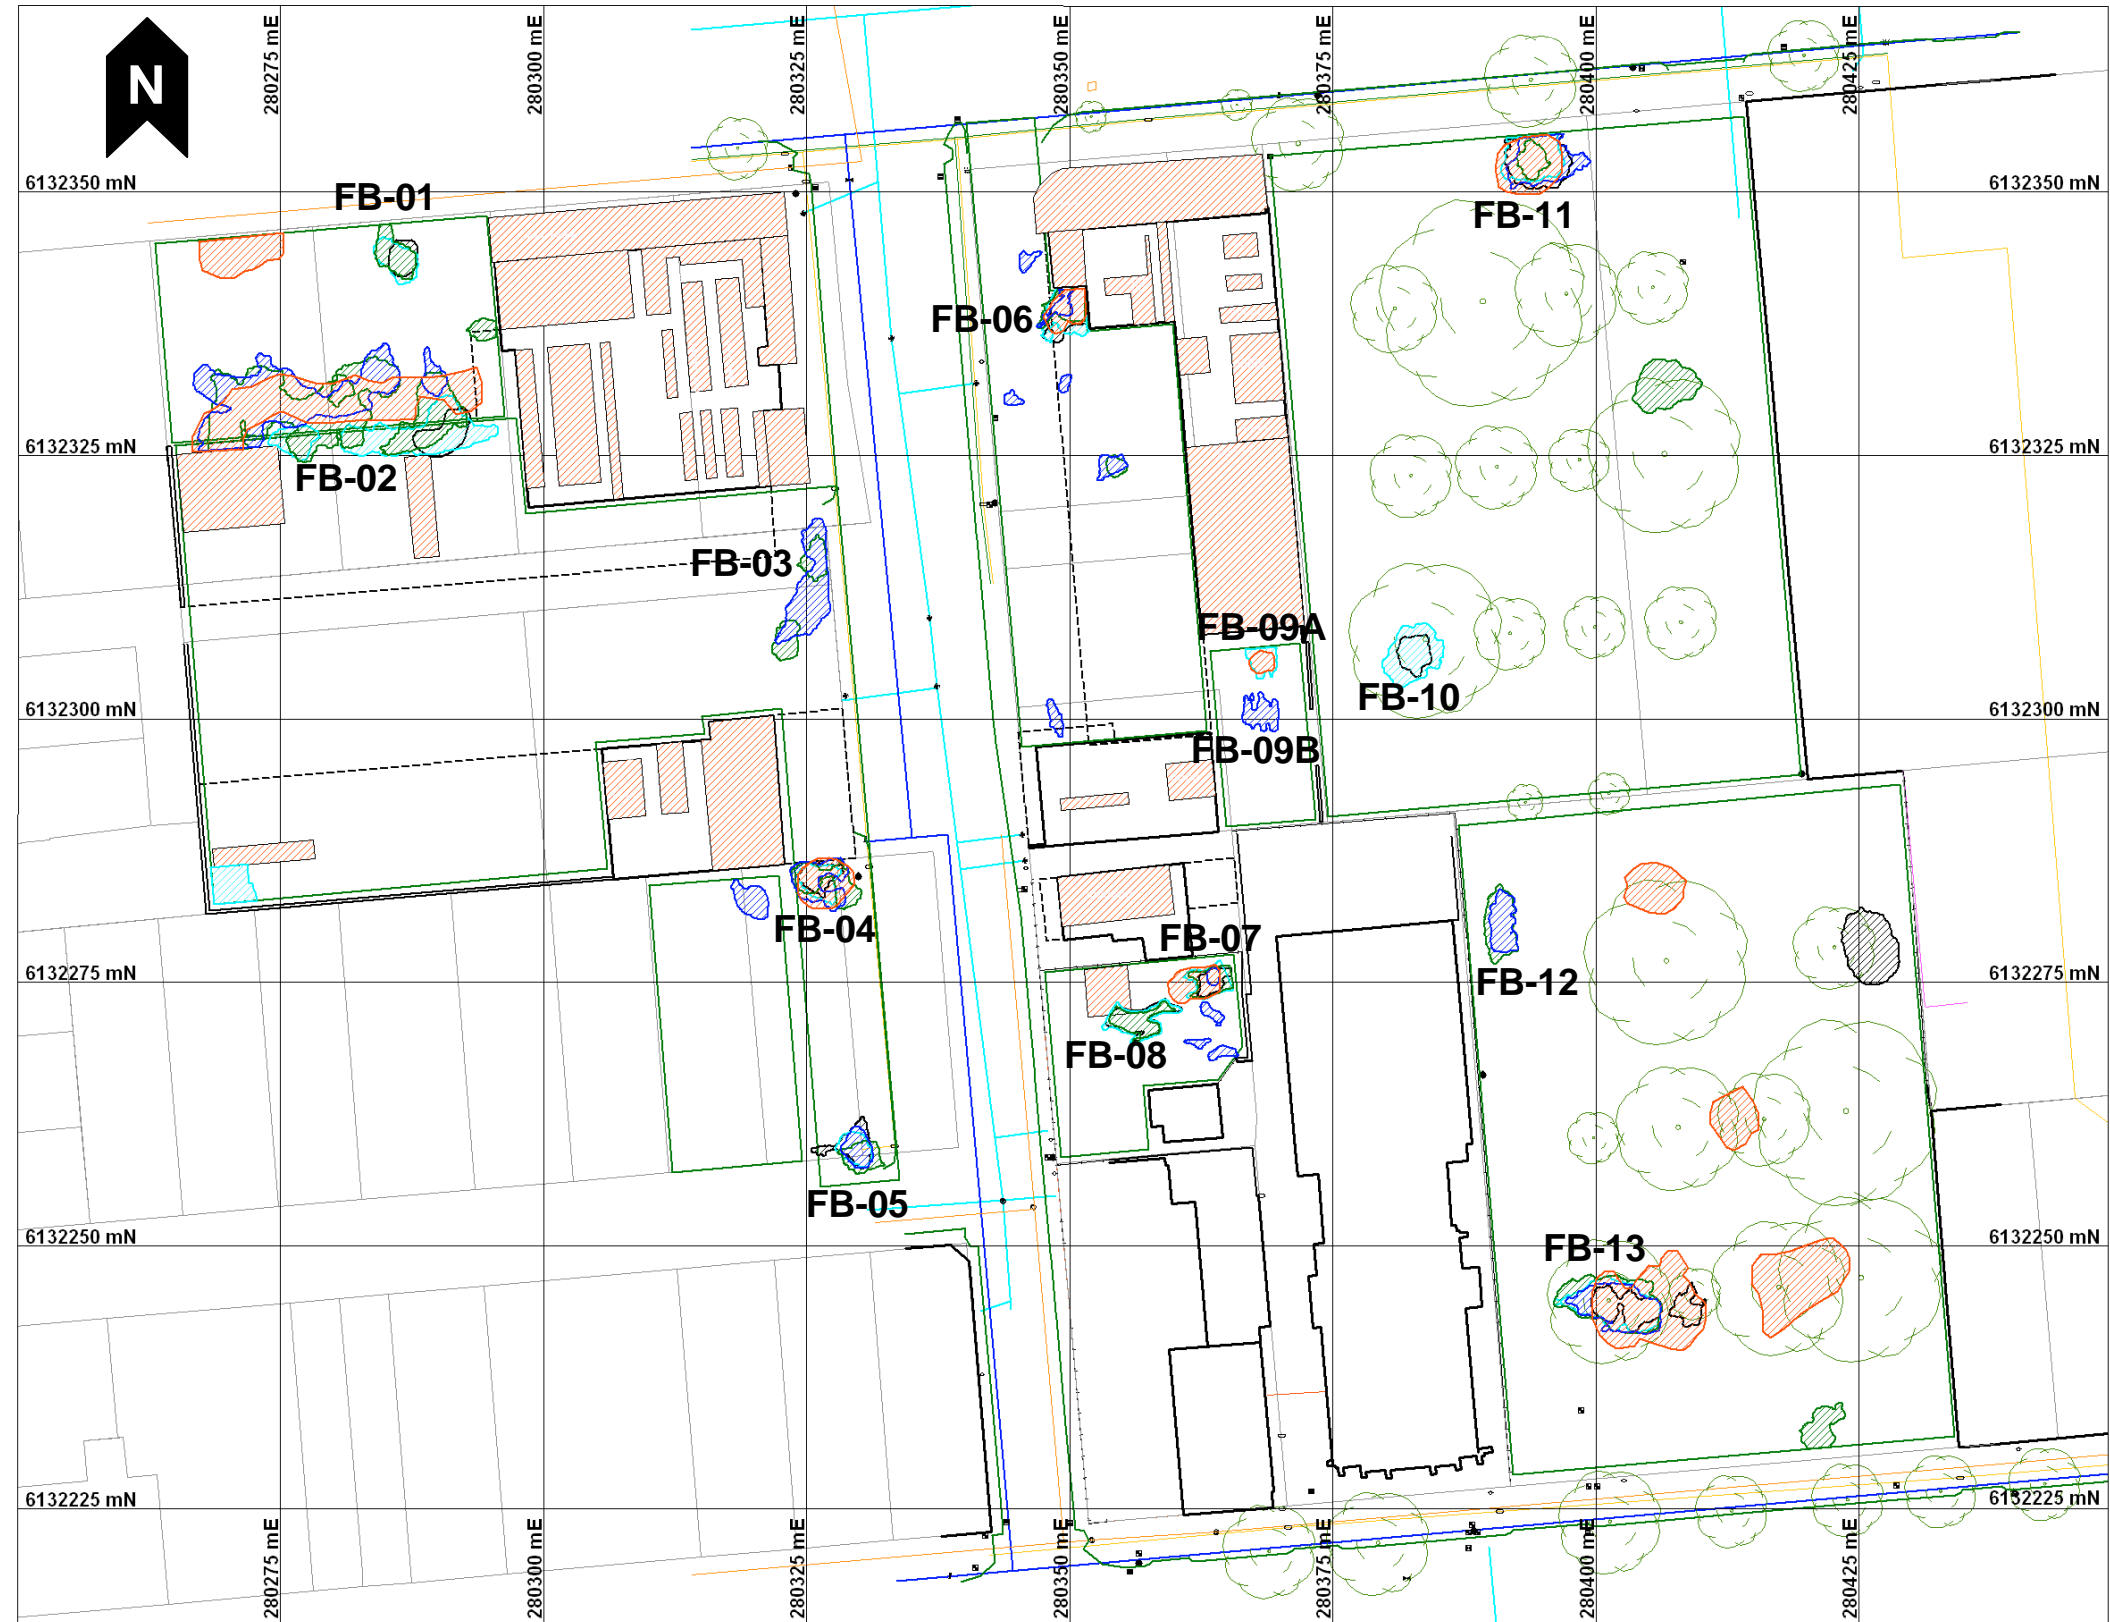
SHEET
08

TIERRA ENVIRONMENT PTY. LTD.
 ET 117 – ADELAIDE. BUS TERMINAL UST INVESTIGATION
 FRANKLIN STREET, ADELAIDE CITY, SOUTH AUSTRALIA
EXTERNAL SURVEY AREAS – COMPILED ANOMALIES

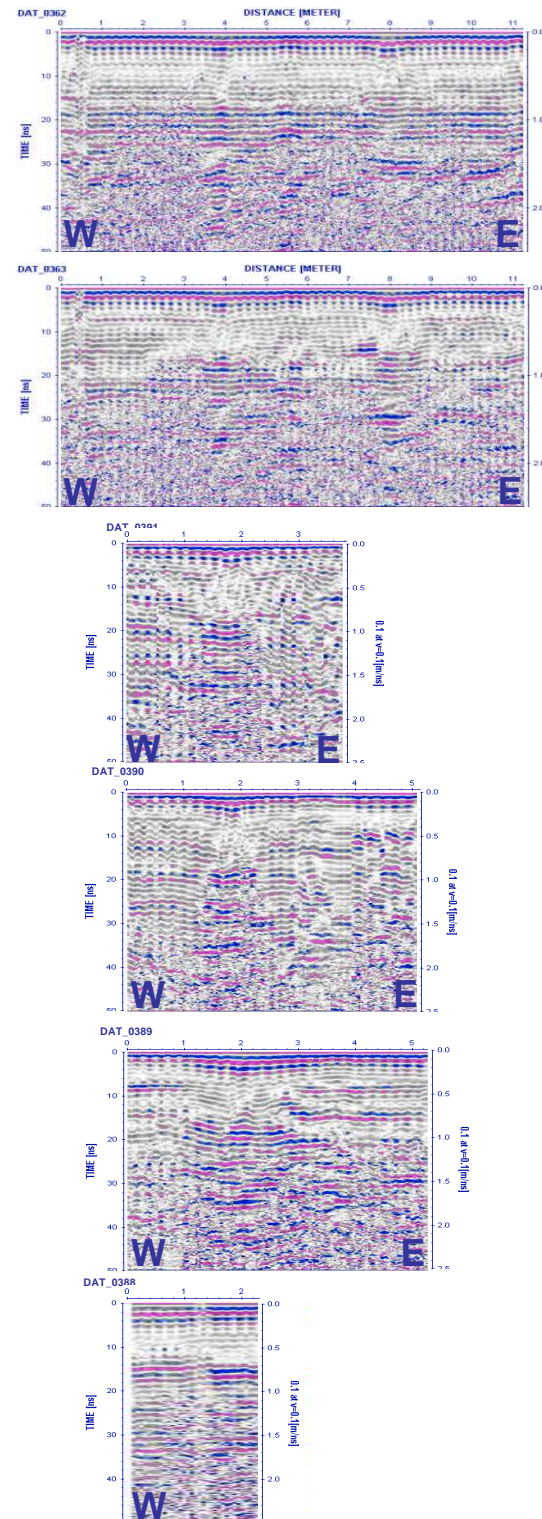
SHEET
14

TIERRA ENVIRONMENT PTY. LTD.
 ET 117 – ADELAIDE. BUS TERMINAL UST INVESTIGATION
 FRANKLIN STREET, ADELAIDE CITY, SOUTH AUSTRALIA
ANOMALY ANALYSIS FB-12 & FB-13
