Re: Response to Request for Information – DA 25038676, 1 - 3 Spence Avenue and 380 Glen Osmond Road, Myrtle Bank

Preliminary Site Investigation and Targeted Environmental Assessment

Carmelite Aged Care

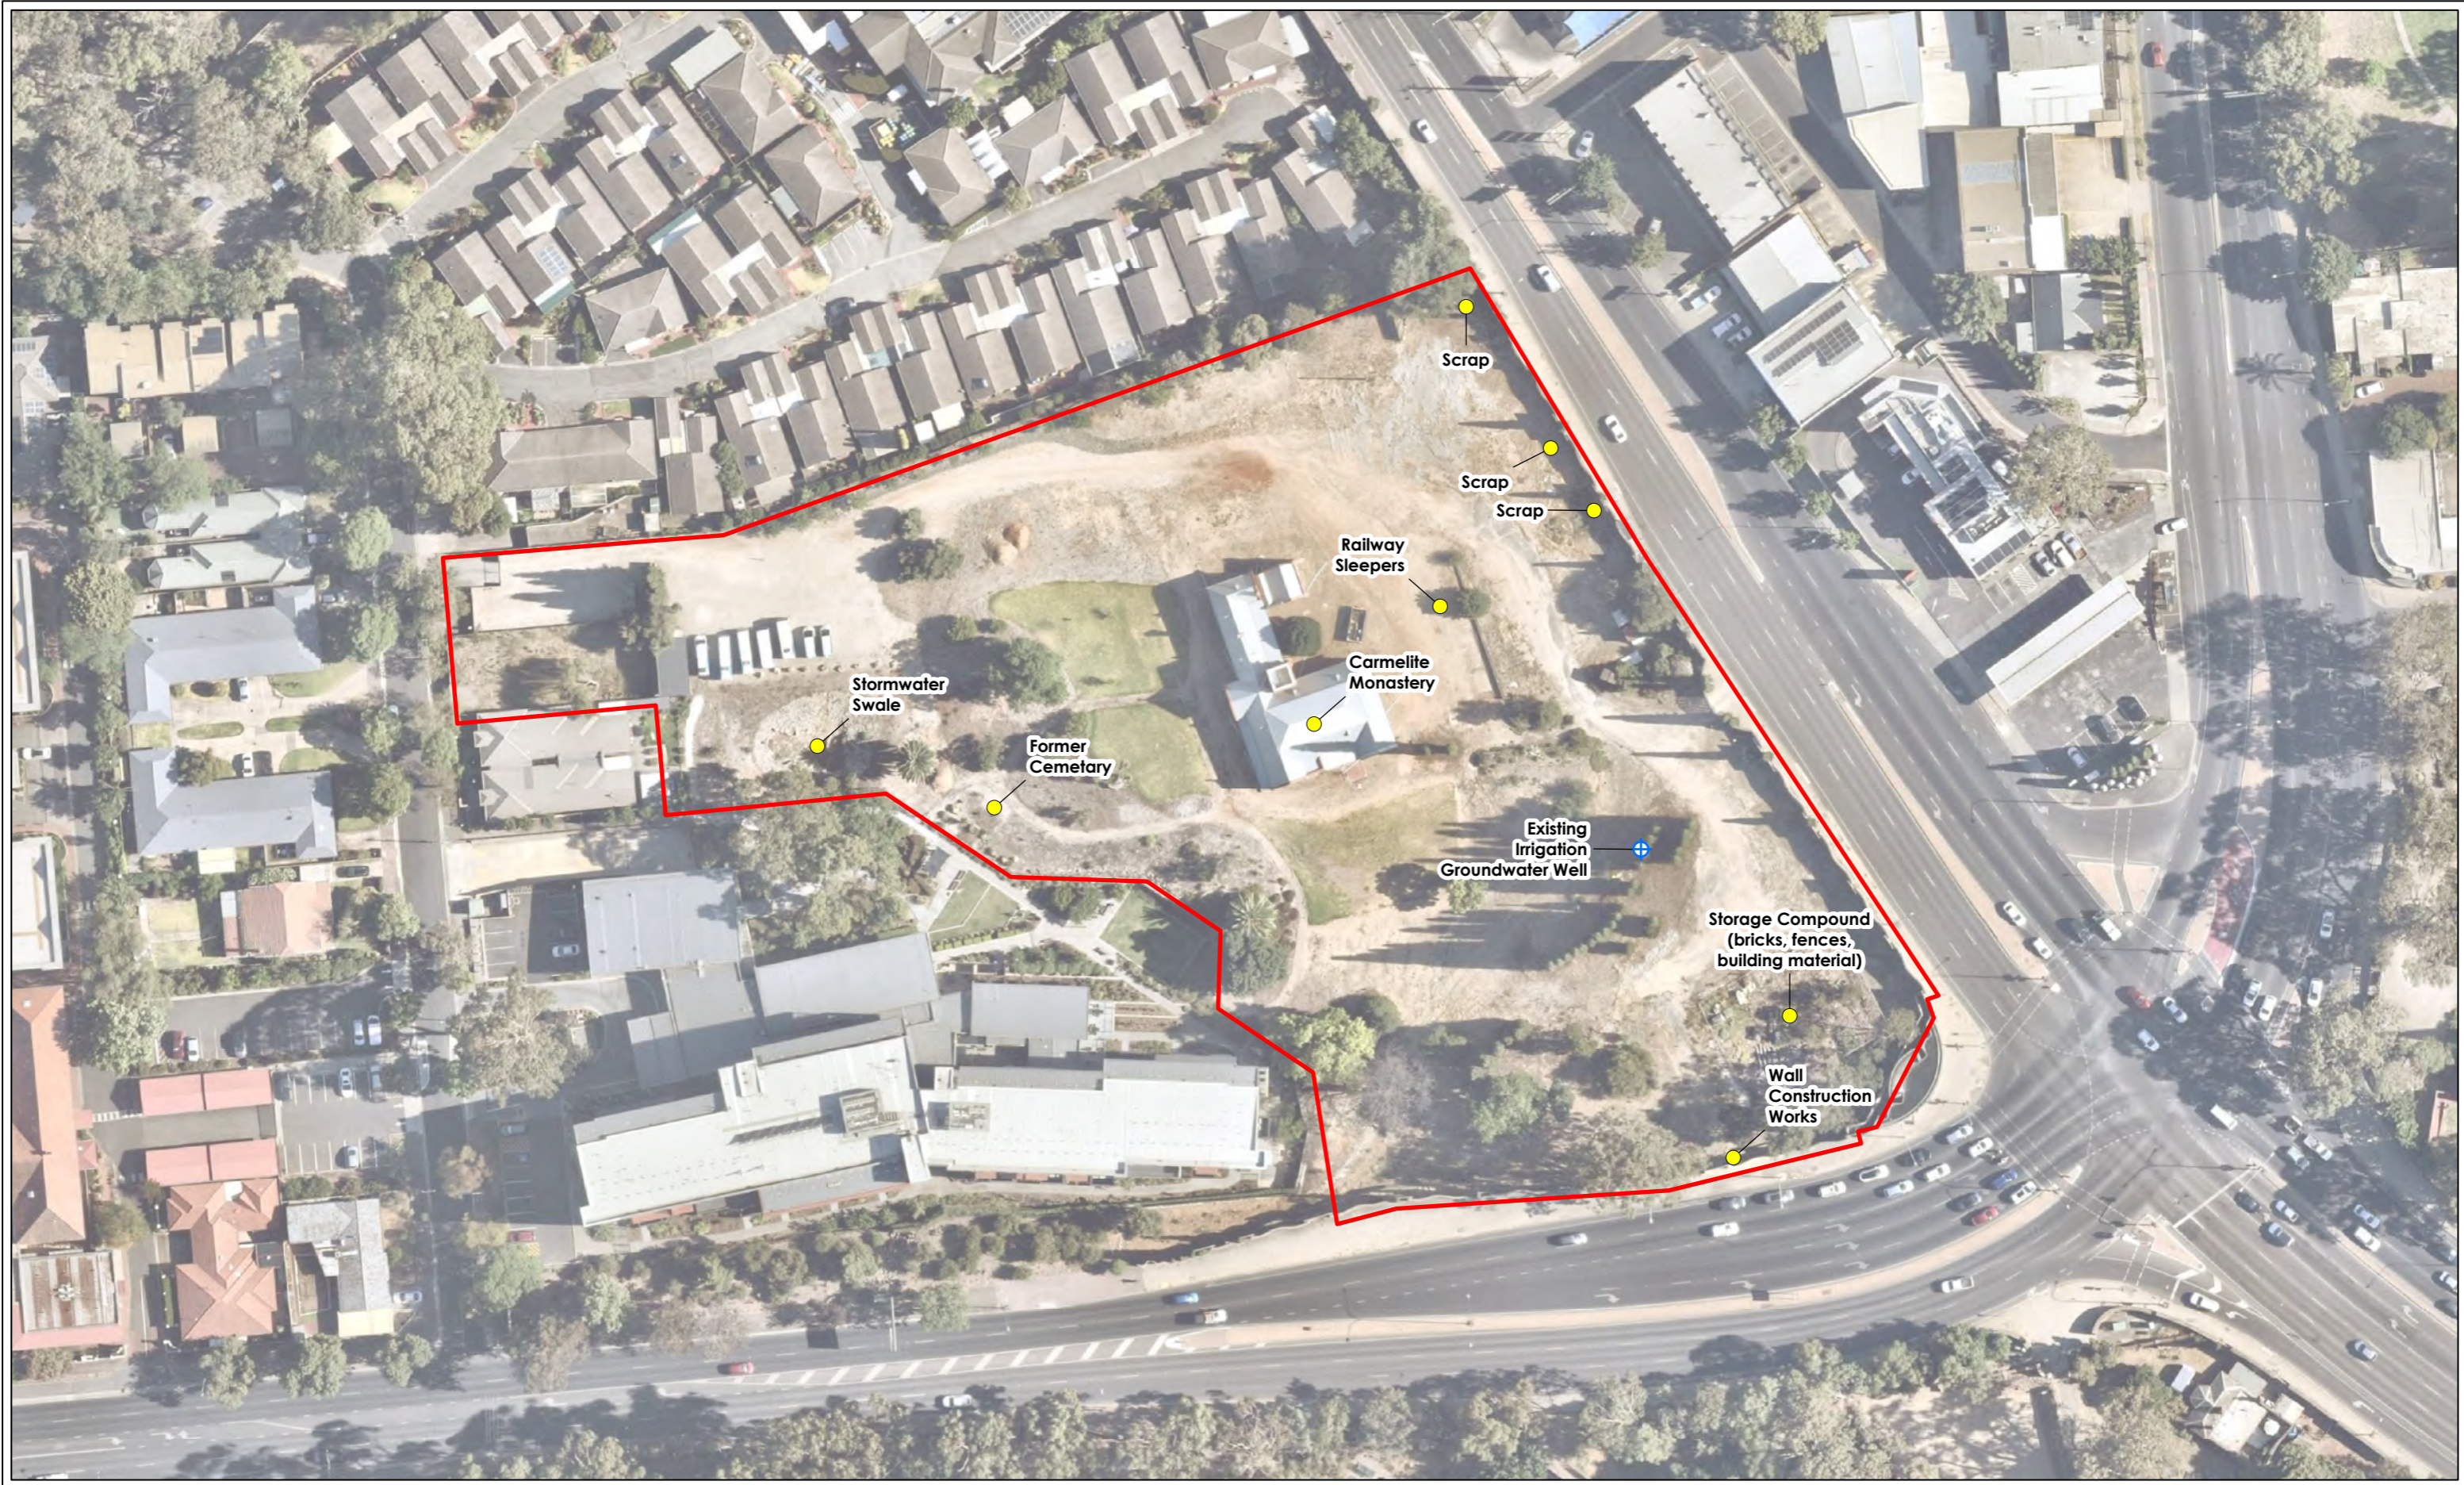
SOUTHERN CROSS CARE		
MYRTLE BANK		
PRELIMINARY SITE INVESTIGATION		
SITE LAYOUT		
PROJECT No.	SHEET No.	REV:
0512.09_SCC	002	A

A figure detailing the points of interest found during the site walkover are provided at the end of this report. Photographs taken during the site walkover are provided in Appendix B.

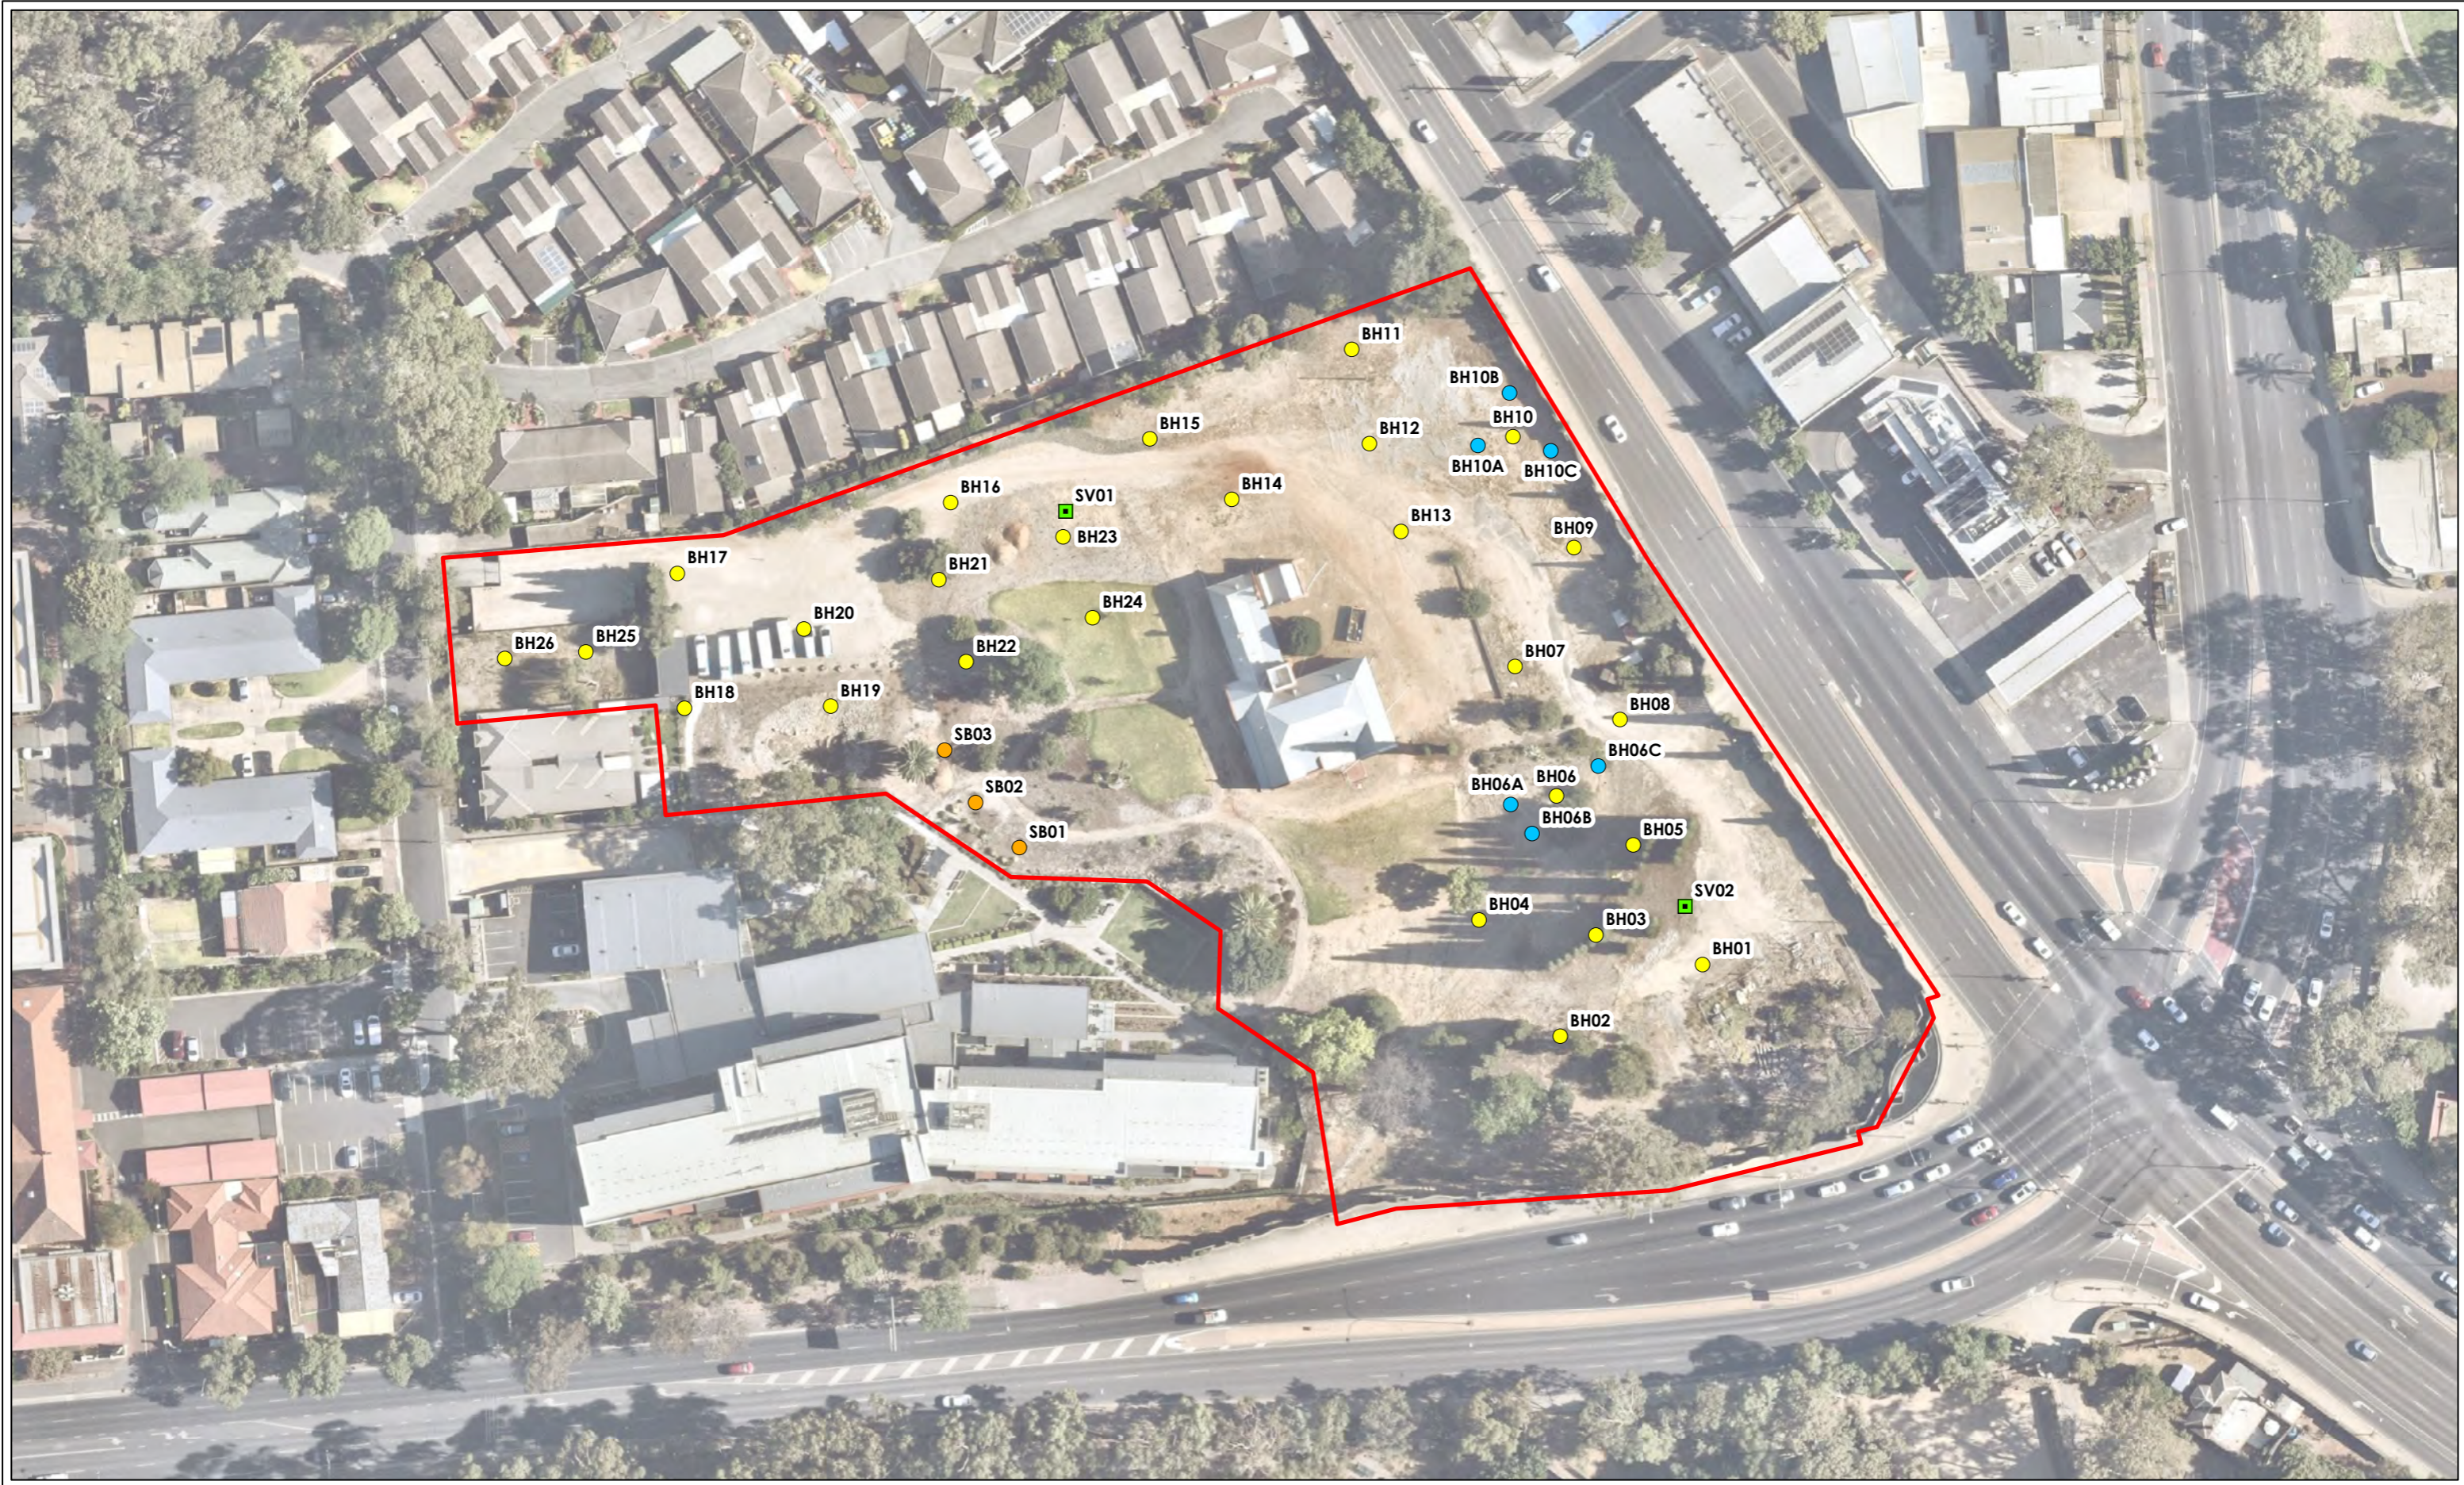
SOUTHERN CROSS CARE		
MYRTLE BANK		
ADDITIONAL ENVIRONMENTAL INVESTIGATION		
SAMPLE LOCATIONS		
PROJECT No.	SHEET No.	REV:
0512.09_SCC	004	A

- Site Boundary
- Sample Location - 2026
 - Soil Bore
 - Soil Vapour Bore
- Sample Location - 2023
 - Soil Bore
 - Validation Soil Bore

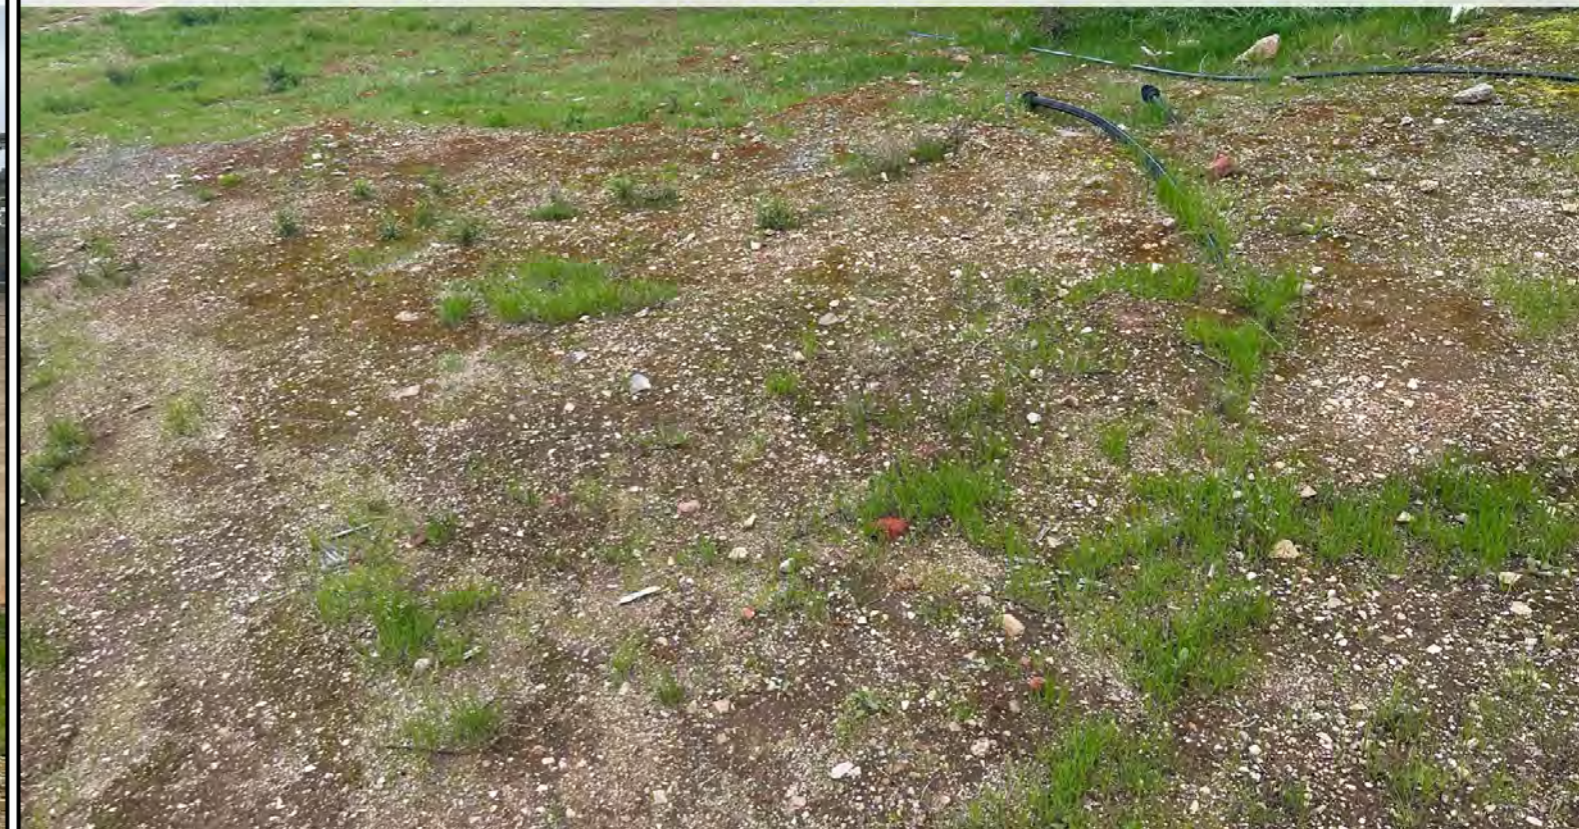
- Earthworks appear to have occurred across the site, as indicated by surface levelling. Imported fill was also observed across the ground surface of the site which comprised coarse gravels to sandy gravels.

GENERAL SURFACE SOIL CONDITION ACROSS THE EASTERN PORTION OF SITE (FILL)

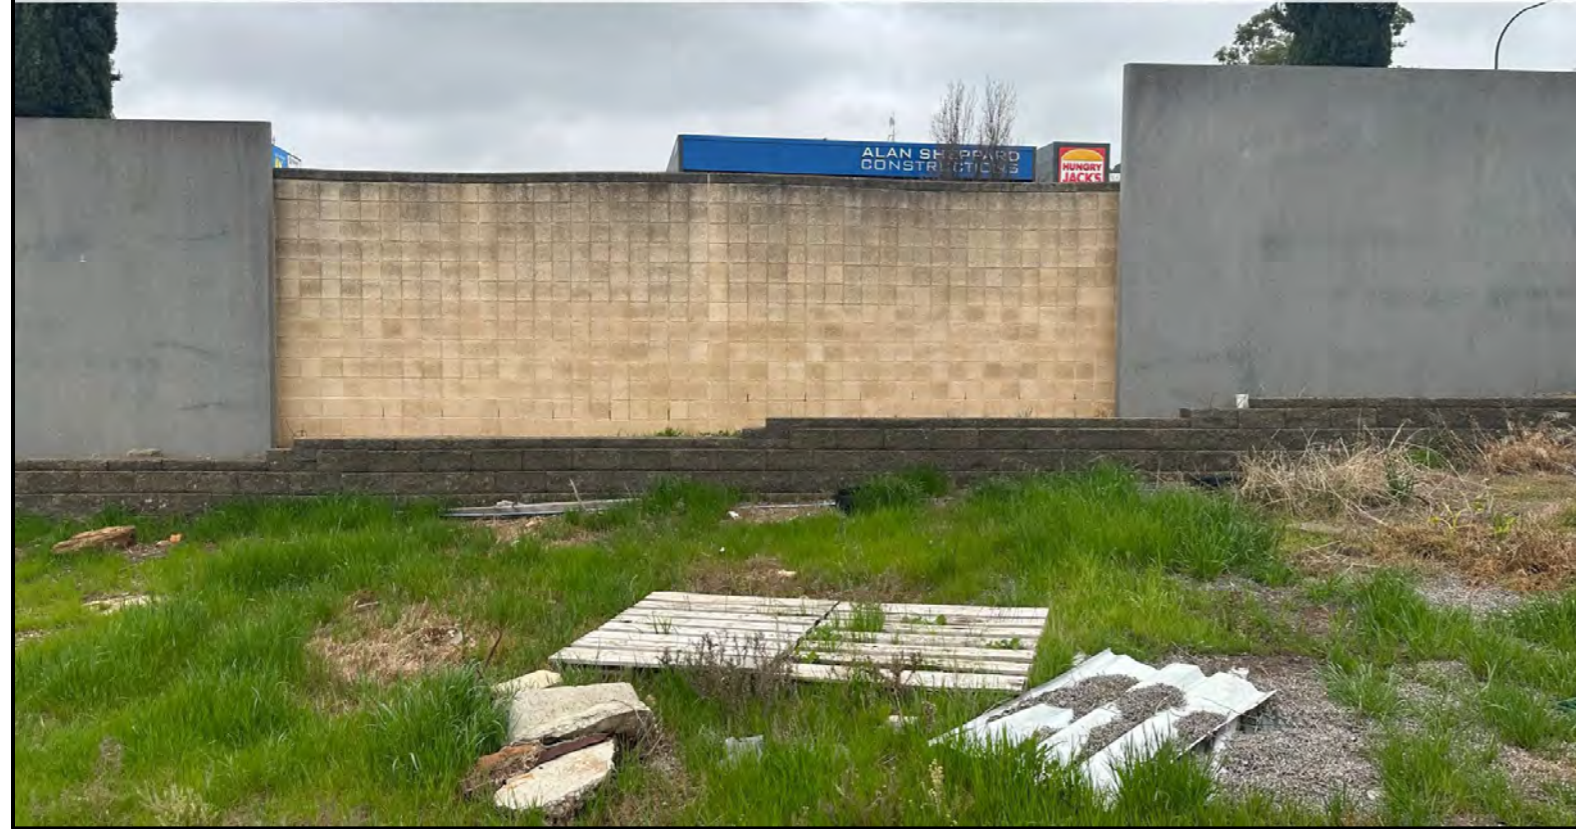
- Some localised dumping of material was noted, predominantly towards the eastern boundary of the site. Material was mostly inert, and included wood pieces, pallets, metal sheeting, metal frames/fencing, bricks and pavers.

DISCARDED MATERIALS (EASTERN BOUNDARY)

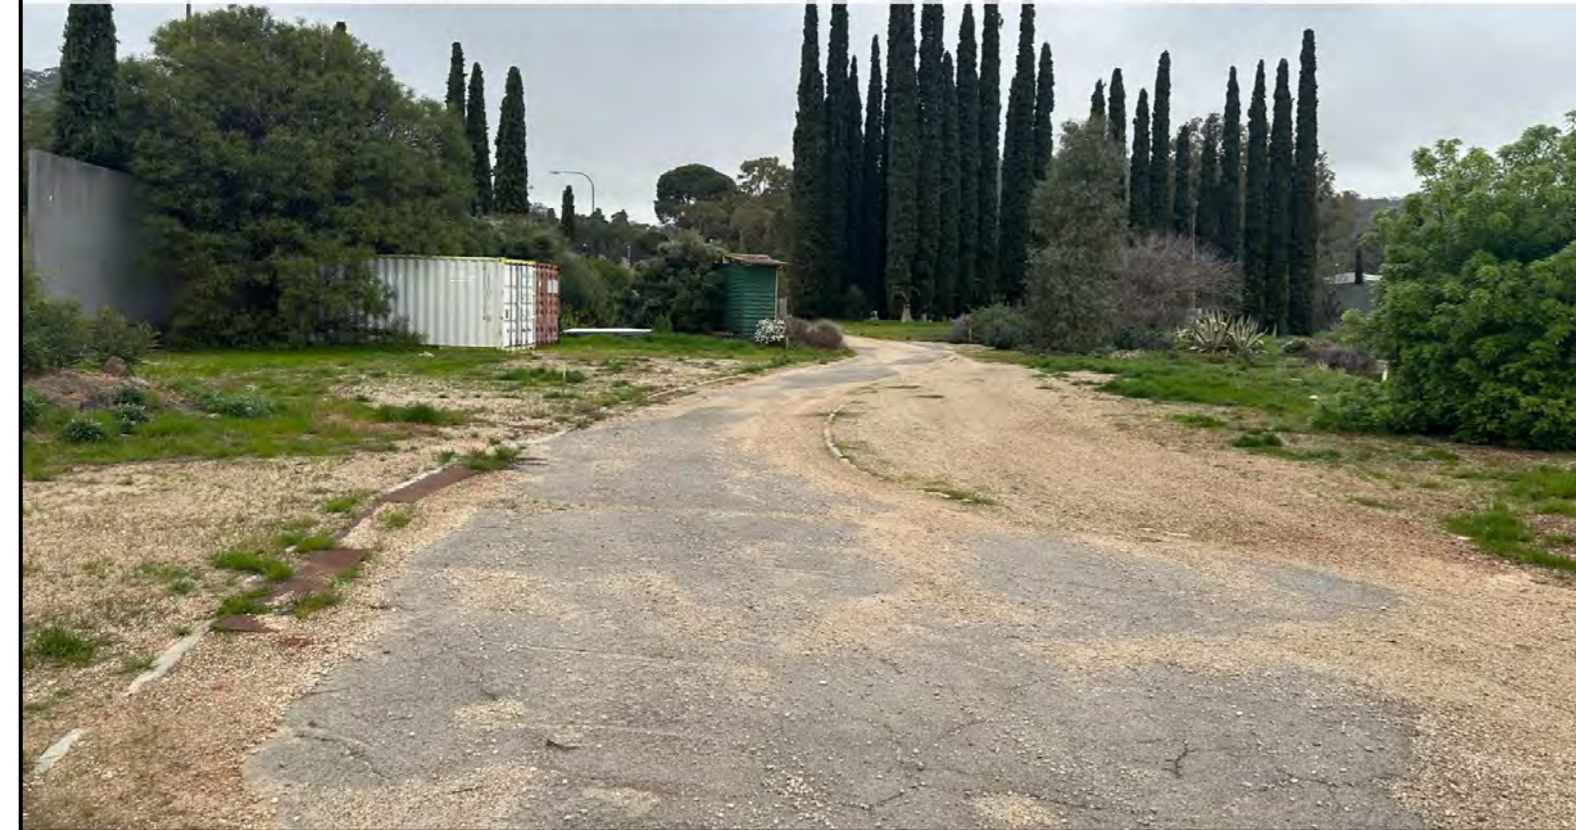
- A sealed asphalt road extending from the eastern boundary towards the Carmelite Monastery was observed. The asphalt appeared to be aged and in fair condition, with some cracking across the profile.

INTERNAL ASPHALT ROAD

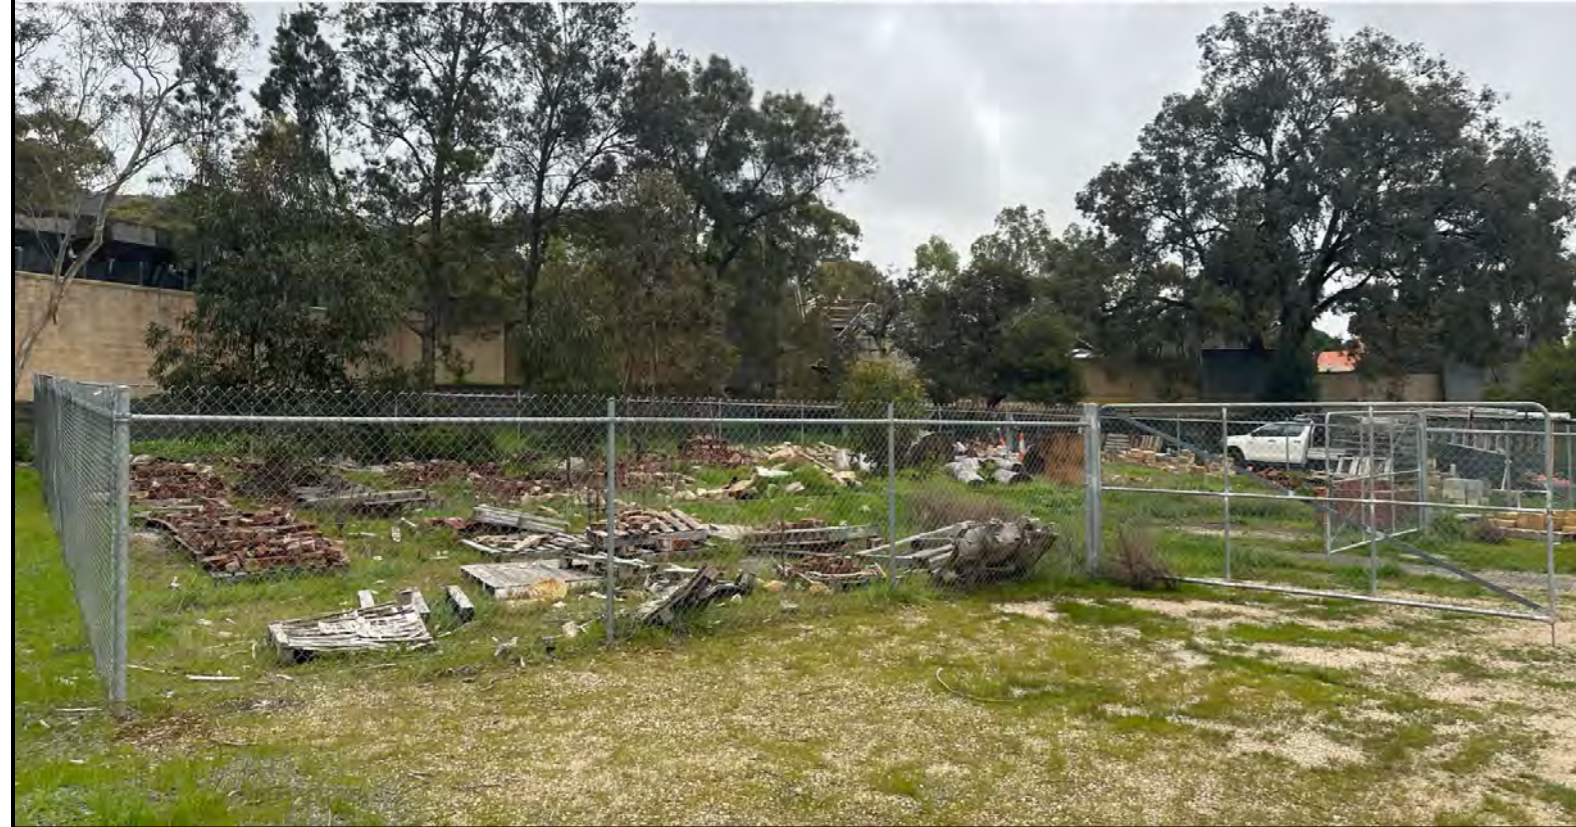
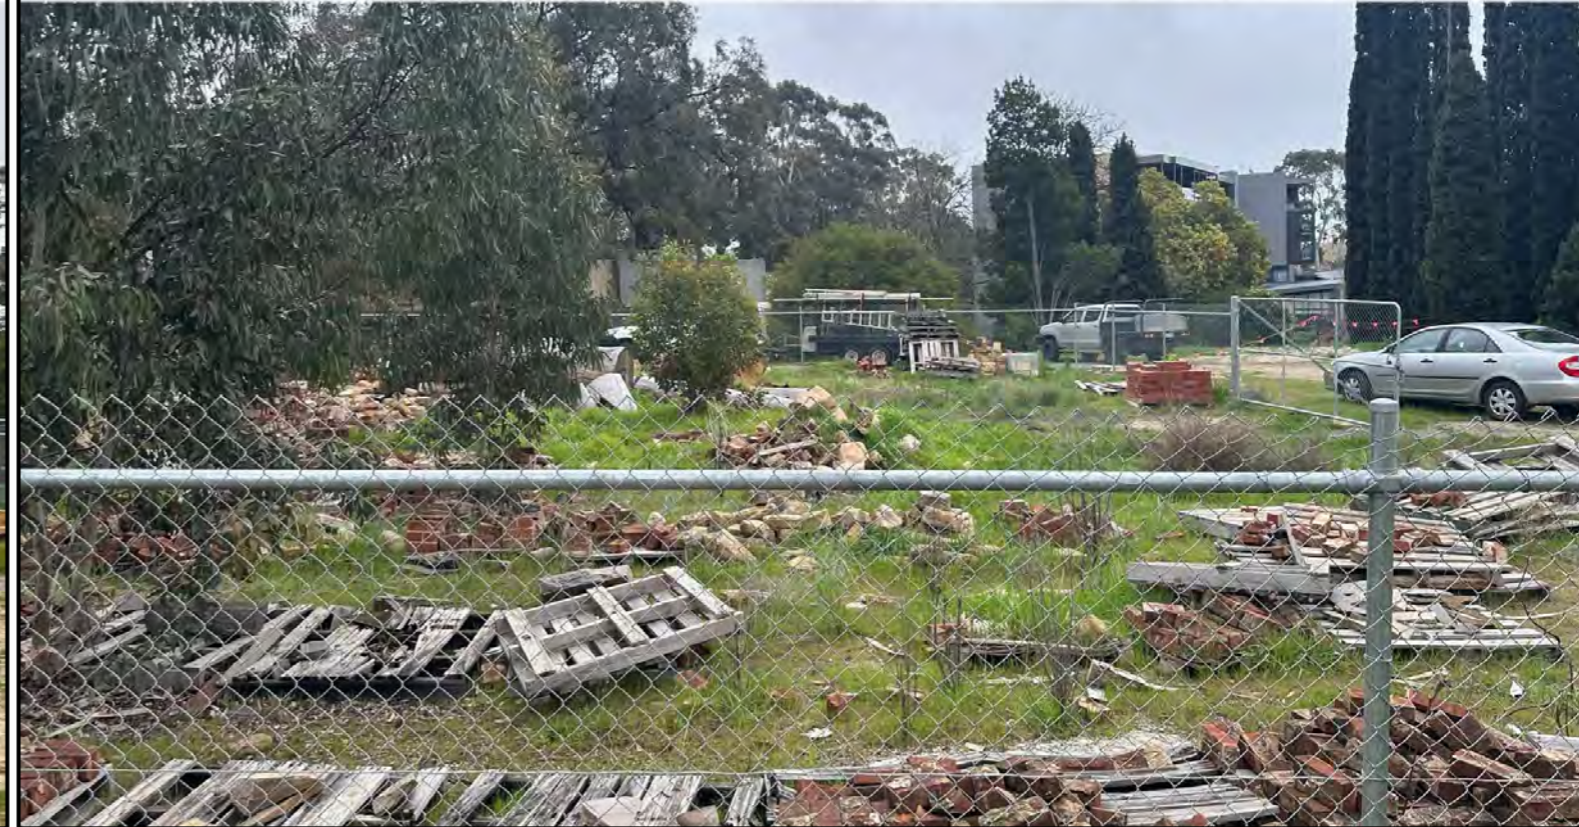
- A fenced off area in the south-eastern portion of the site was observed, containing various discarded construction materials such as bricks/pallets.
- The site generally slopes towards the west, with a creek located between the subject site and the adjacent aged care facility to the southwest. A stormwater swale is located in the valley, towards the south-west of the site Culverts located in the swale likely lead off site and lead downstream towards Glen Osmond Creek.

FENCED OFF AREA CONTAINING BRICKS, PALLETS AND OTHER BUILDING MATERIALS

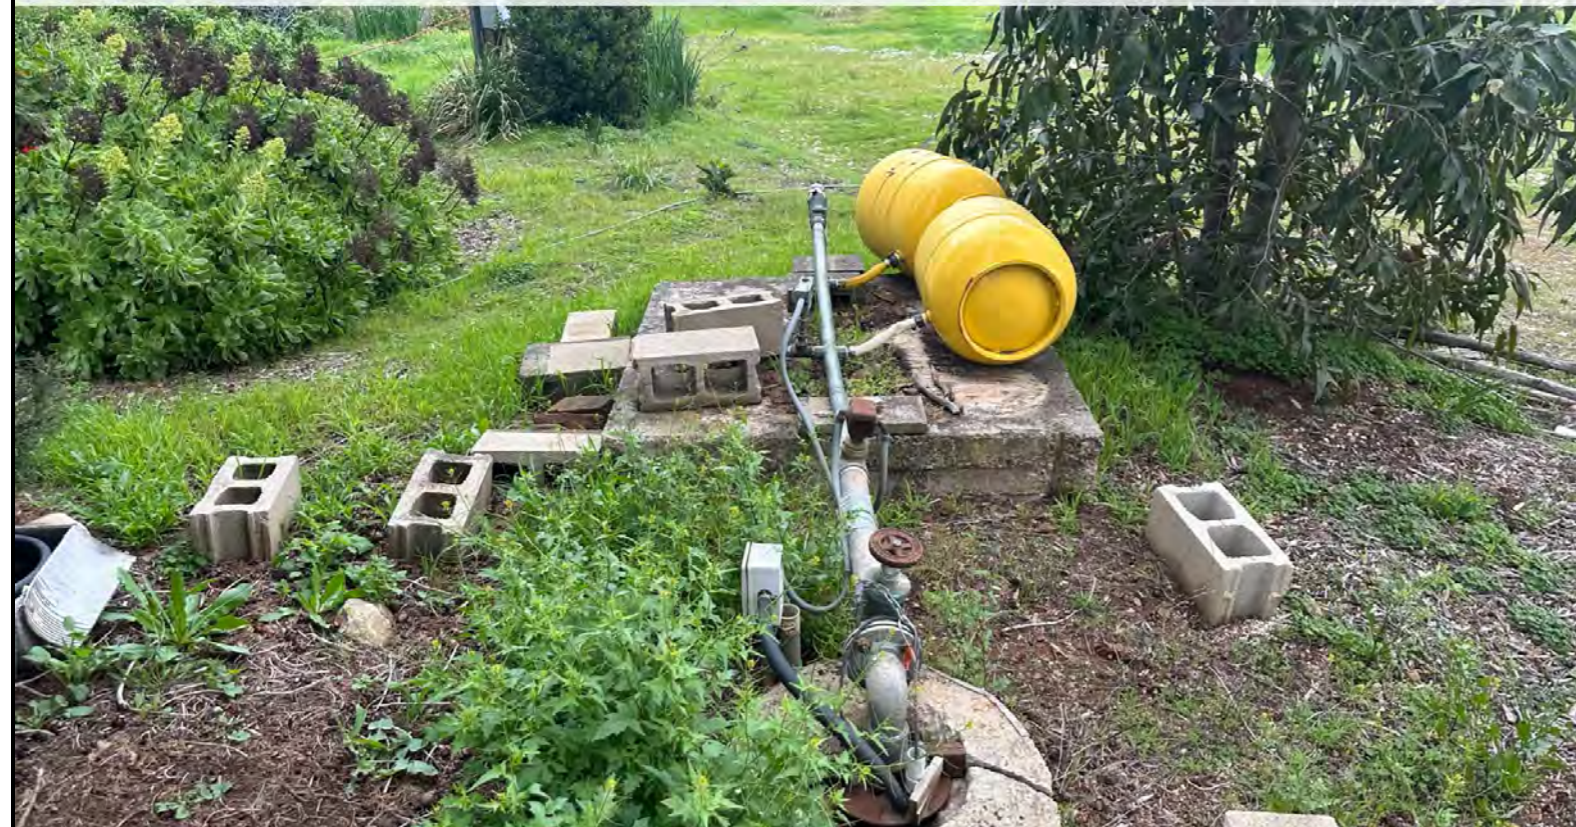
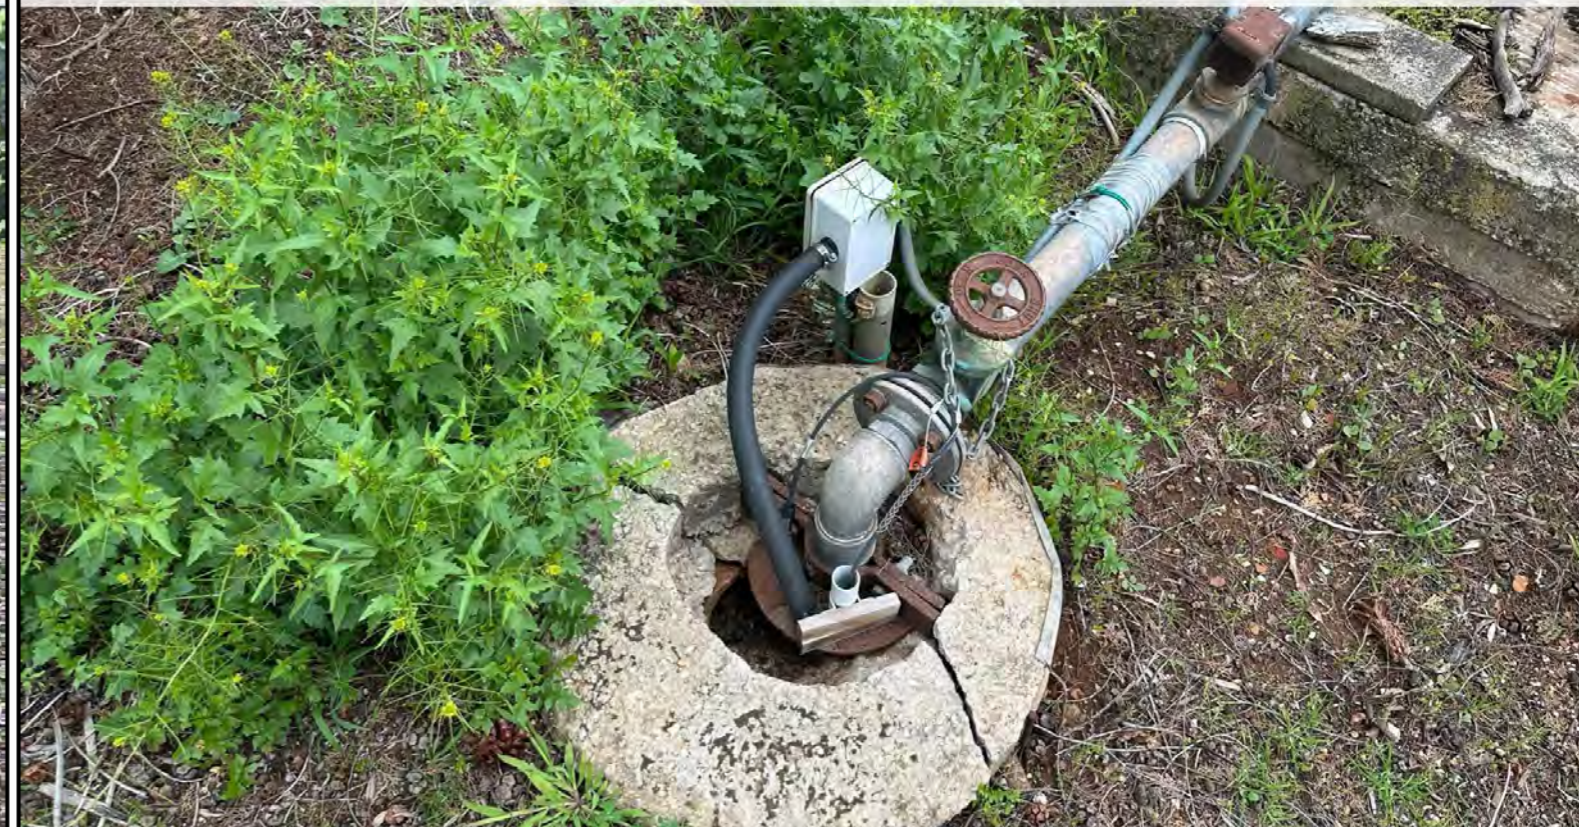
- A groundwater bore was located toward the eastern portion of the site. Pumping equipment was noted to be in fair condition. It is unknown whether the bore is currently in use. Two small above ground tanks were connected as part of the irrigation system.

- Southern Cross acquired the original site, encompassing around 24,000 m² from the Carmelite Nun's Order in 2009.
- The groundwater bore located on site (and observed during the site inspection) is not currently in use. It has however been used for garden irrigation, when required.
- The fenced compound located towards the southeastern portion of the site is used for storage purposes of rare, recovered bricks from the original state heritage building (Carmelite Monastery) for salvage/reuse.
- The remains in the cemetery located towards the west of the original orchard area were relocated off site as part of the Carmelite Nun's orders vacancy from the site (2009).
- No herbicides or pesticides have been known to have been used on site.

During the site inspection (refer Section 2.3), Ennovo personnel identified an on-site well which appeared to be used for irrigation. It is noted there is no record of this well on the Waterconnect database. Environmental Projects (EP) sampled what is believed to be the on-site well and determined the SWL to be 7.602 m bgl, the EC as 1,945 μ S/cm and pH of 7.44.

GROUNDWATER BORE

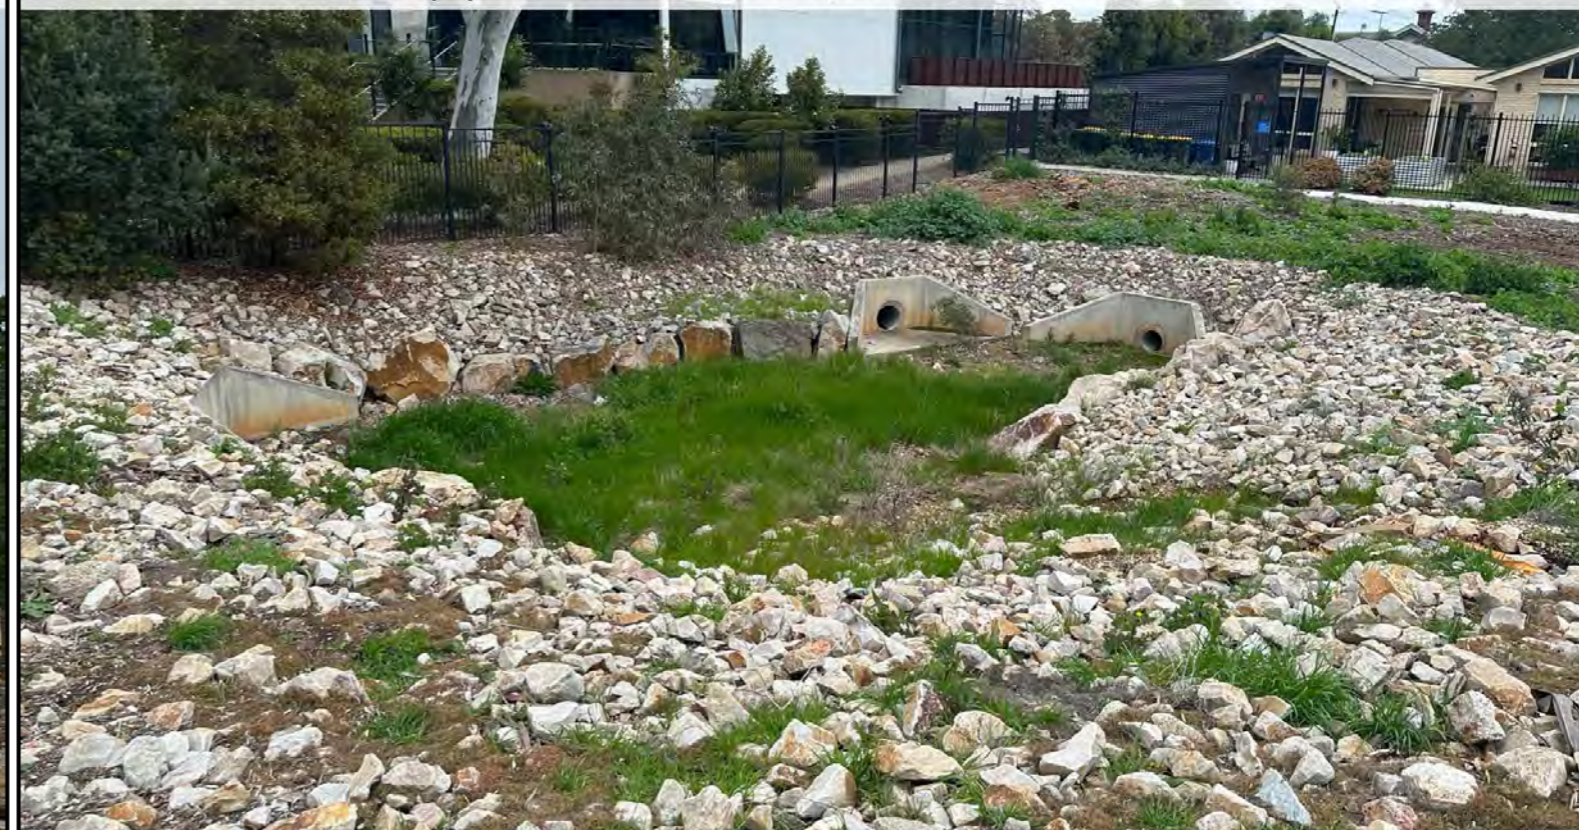
The nearest watercourse is the Glen Osmond Creek located directly north west of the site. It is understood the creek previously extended across the western portion, which has been backfilled and replaced with a stormwater swale located in the north-western portion of the site.

STORMWATER SWALE LOCATED TOWARDS SOUTHWESTERN PORTION OF SITE

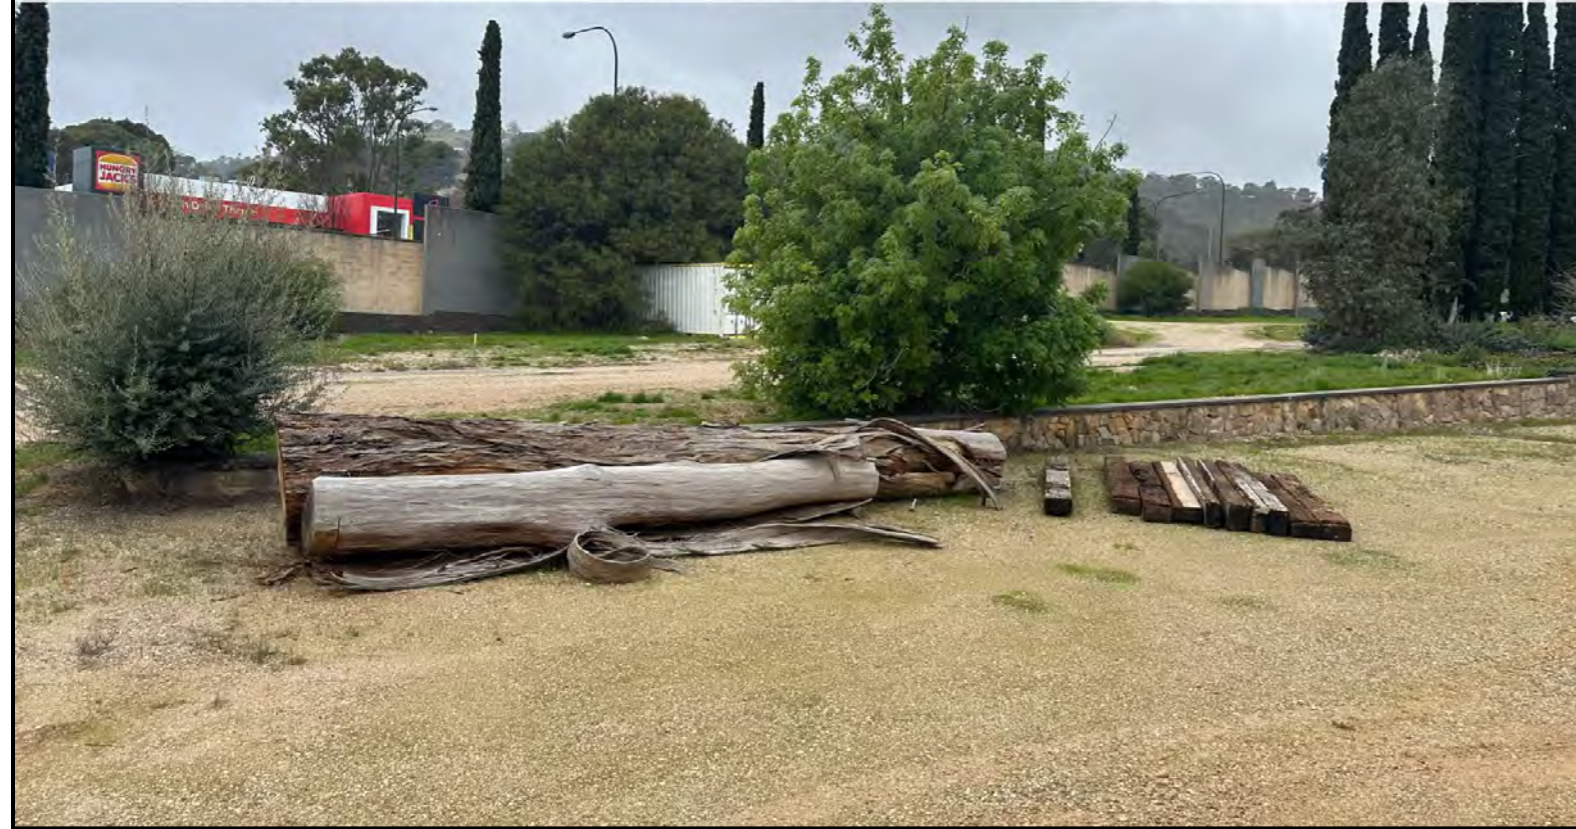
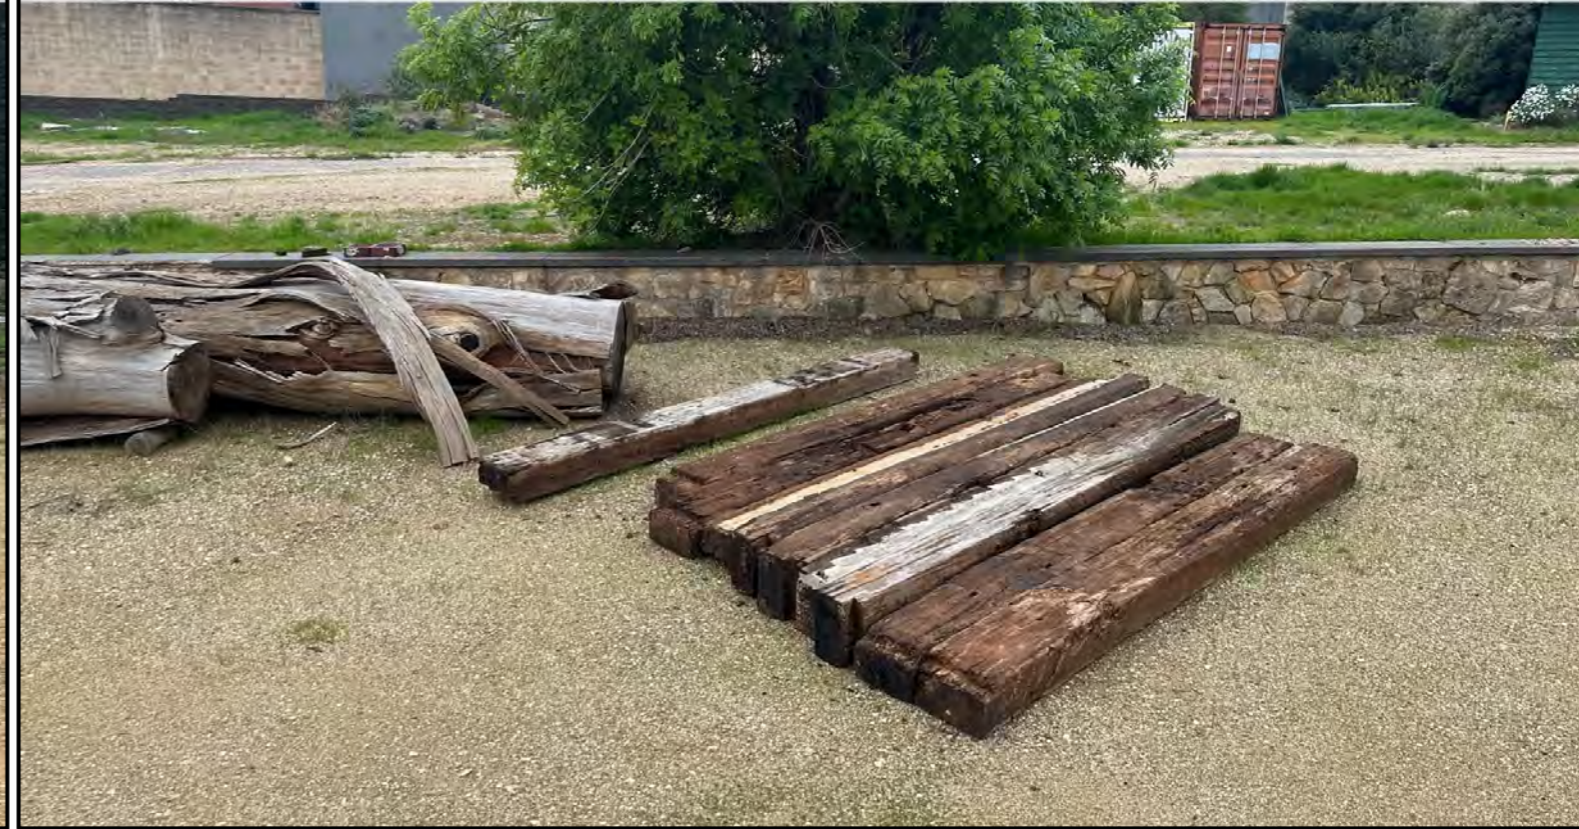
DISCARDED WOOD LOGS AND RAILWAY SLEEPERS
