Re: Response to Request for Information – DA 25038676, 1 - 3 Spence Avenue and 380 Glen Osmond Road, Myrtle Bank

Preliminary Site Investigation and Targeted Environmental Assessment

Carmelite Aged Care

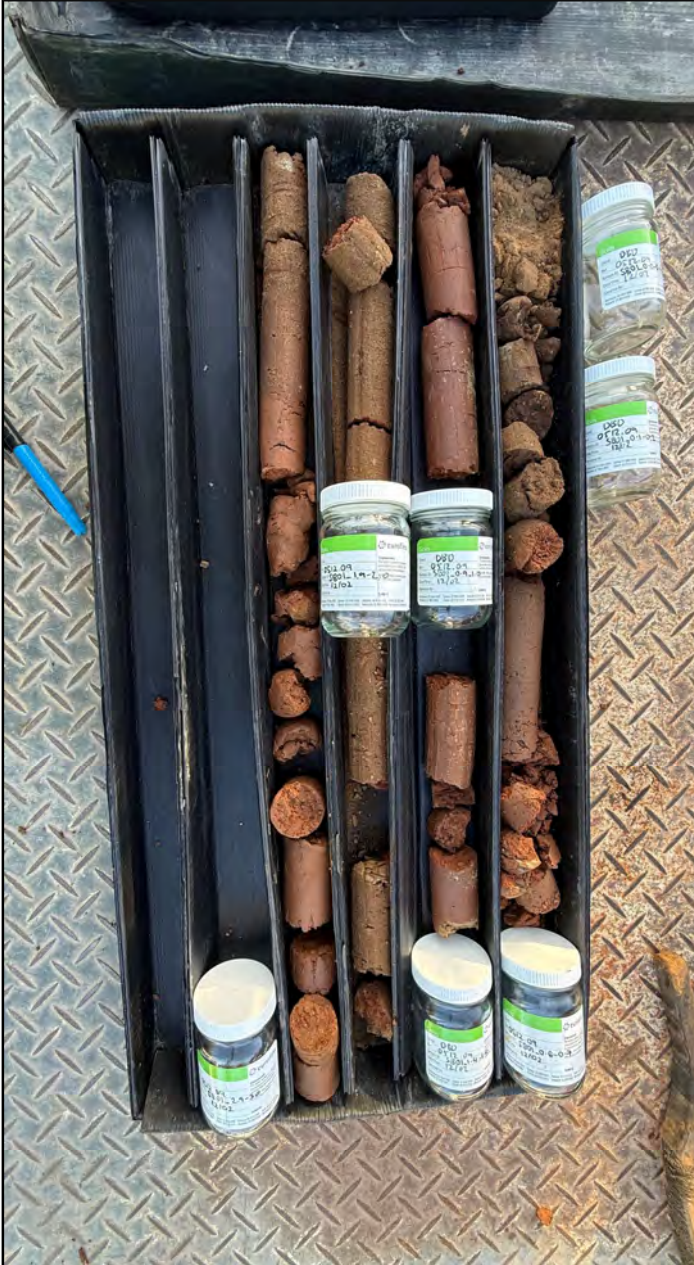
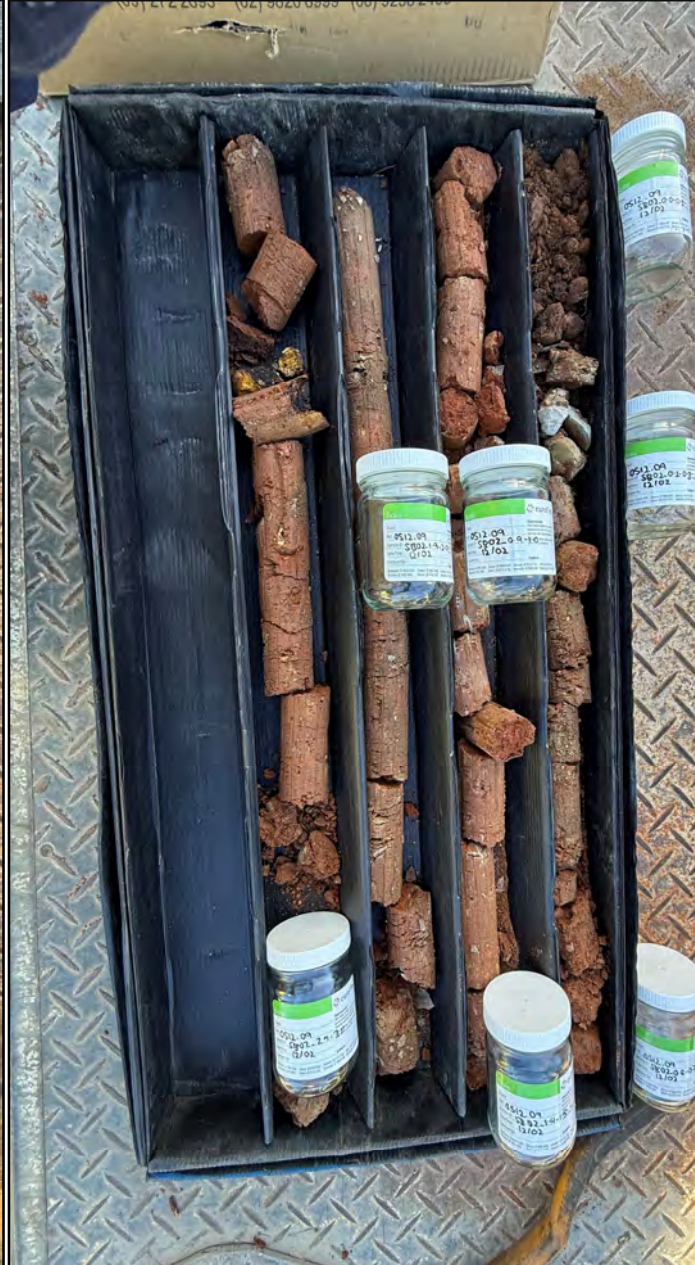
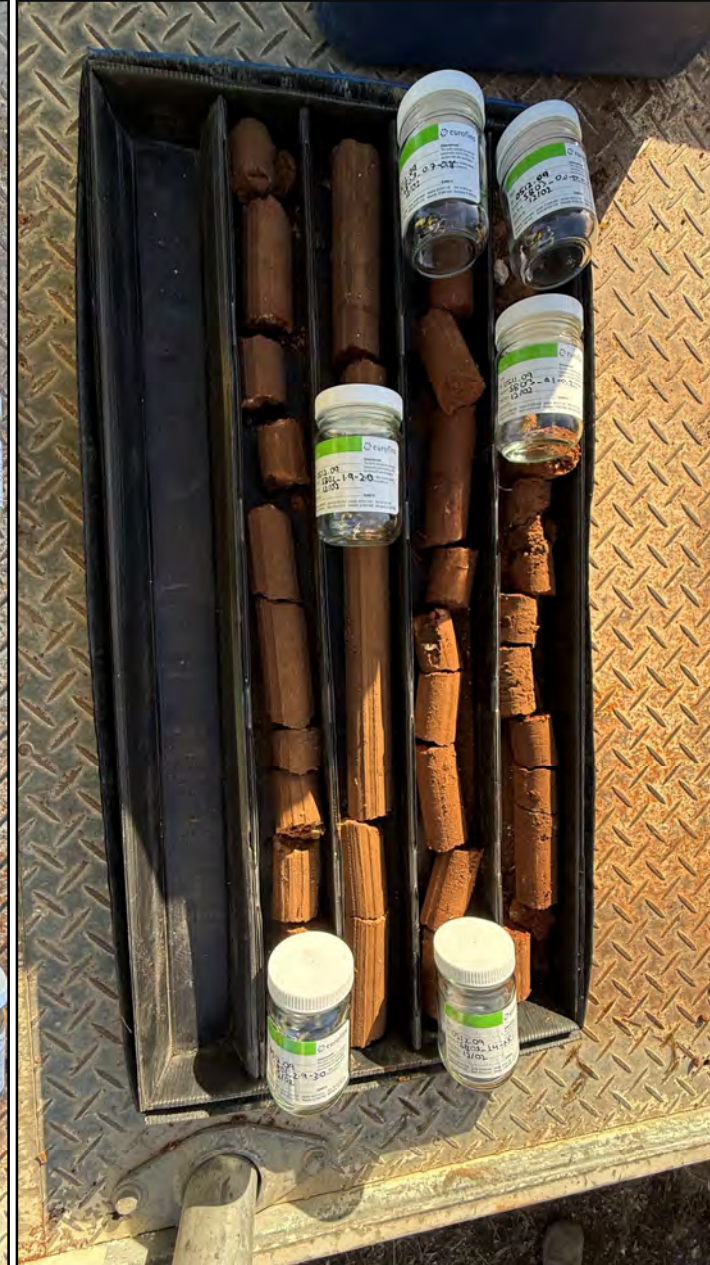
Shallow fill material was encountered at all three soil bore locations, extending to a maximum depth of 0.1 m bgl. Fill material comprised a brown fine to coarse grained gravelly sand, with trace roots. The underlying natural material comprised brown silty clay with moderate plasticity and minor gravel inclusions. No asbestos containing material or stained/odorous soils were encountered during sampling.

SB01 CORE TRAY

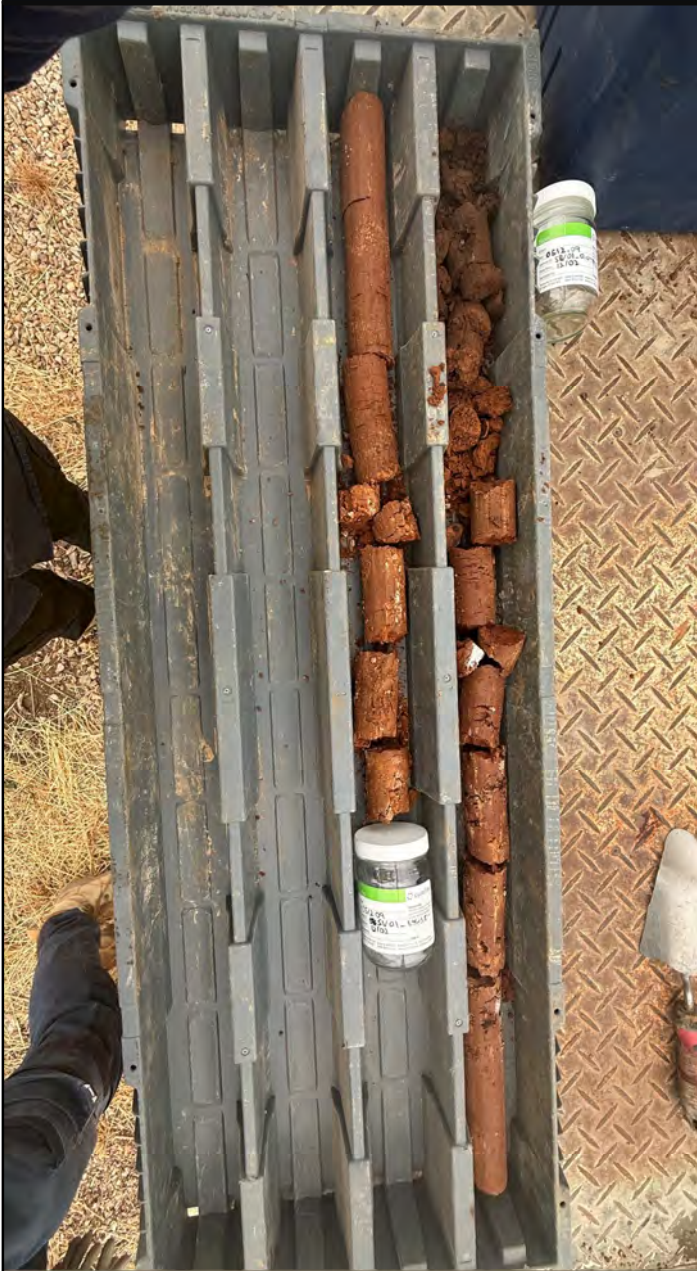
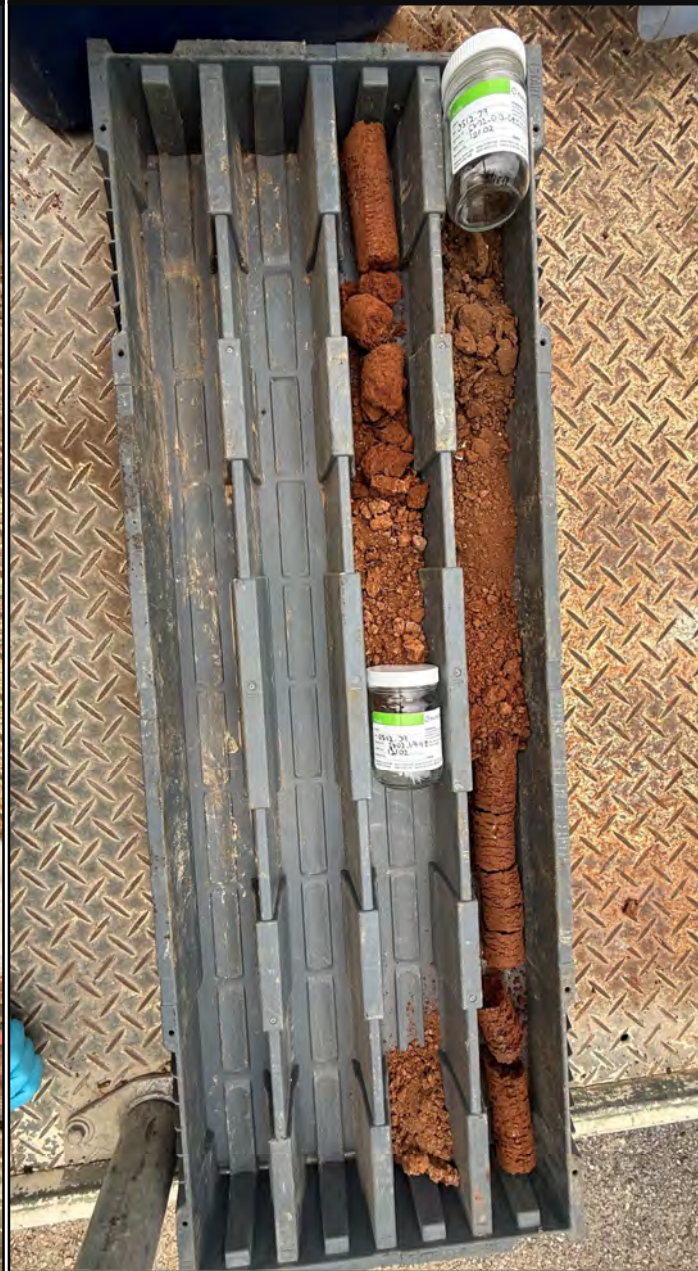
A stainless-steel implant (approximately 200 mm in length) was connected to a length of 1/4 inch Teflon tubing (terminating at the surface) and placed at 1.4 m bgl. A sand pack (grain size of 2-3 mm) was placed at the base of each hole surrounding the stainless-steel screen to approximately 200 mm above the screen. A hydrated bentonite seal was then placed surrounding the Teflon tubing to the surface. Each vapour point was finished at the surface with a concreted flush gatic cover protecting the upper end of the tubing, which was terminated with a plastic cap.

SV01 CORE TRAY
